**HISTORIC RESOURCES INVENTORY:**  
 Buildings & Structures

**SURVEY OF GUILFORD, NEW HAVEN COUNTY, 06437**  
 June-December 1981

1. ADDRESS 387 Boston Street  
(map 48, lot 56)
2. NAME  
(historic) Jason Seward  
NAME  
(common)
3. USE  
(historic)  
USE  
(present) Private house
4. IF MOVED, WHEN AND FROM WHERE:

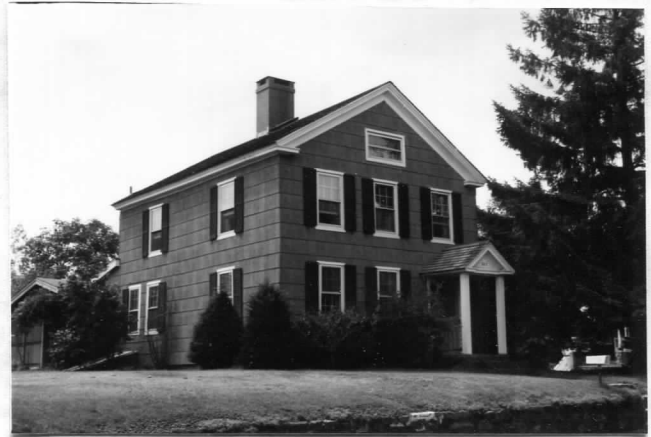
5. ARCHITECT
6. DATE c1837
- BUILDER
- STYLE Greek Revival
7. ALTERATIONS  
Asbestos shingles; rear porch and probably the posts and railings of the front porch are all modern. The roof of the porch, quite out of character with the Greek Revival, may be modern too. Gable window evidently altered, now missing the usual muntins.
8. NOTABLE FEATURES

9. ARCHITECTURAL-HISTORICAL  
An early example of Greek Revival in Guilford. Building does not have full pediment, gable end to street with cornice returns.
