**HISTORIC RESOURCES INVENTORY:**  
 Buildings & Structures

**SURVEY OF GUILFORD, NEW HAVEN COUNTY, 06437**  
 June-December 1981

1. **ADDRESS** 55 Boston Street  
 (map 40, lot 155)
2. **NAME**  
*(historic)* Ebenezer Hopson  
**NAME**  
*(common)*
3. **USE**  
*(historic)*  
**USE**  
*(present)* Apartments
4. **IF MOVED, WHEN AND FROM WHERE:**

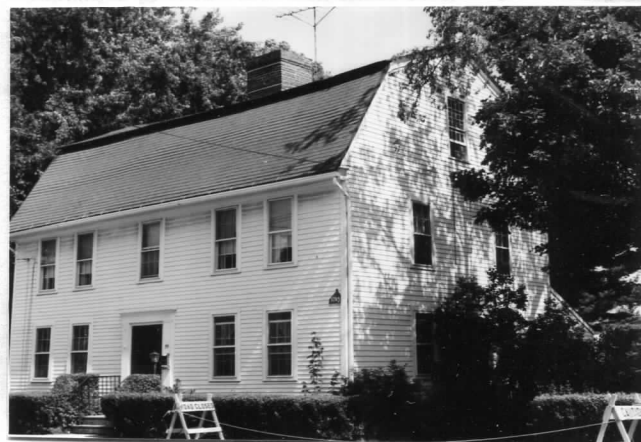
5. **ARCHITECT**
6. **DATE** 1763 **BUILDER**
- STYLE** Colonial
7. **ALTERATIONS**  
 Shed added on rear; front steps and railings. Chimney appears to have been rebuilt in original size and location.

8. **NOTABLE FEATURES**  
 The door, which is probably a Greek Revival addition of sometime around 1840, is delightful--modest but elegant, with a simple row of little blocks like Greek guttae at the top of each pilaster, and a delicate cornice.
9. **ARCHITECTURAL-HISTORICAL**  
 A house in this neighborhood that has not been covered with synthetic siding and shiny silver window sash is a welcome sight. With its gambrel roof and austere simplicity, this is one of the striking buildings on the street. The first Methodist sermon preached in Guilford, we are told, was preached here, in 1789 by the Reverend Jesse Lee.
