HISTORIC RESOURCES INVENTORY:
 Buildings & Structures

SURVEY OF GUILFORD, NEW HAVEN COUNTY, 06437
 June-December 1981

1. ADDRESS 66 Broad Street
(map 39, lot 33)
2. NAME
(historic) Fowler House
NAME
(common)
3. USE
(historic)
USE
(present) Private house
4. IF MOVED, WHEN AND FROM WHERE:

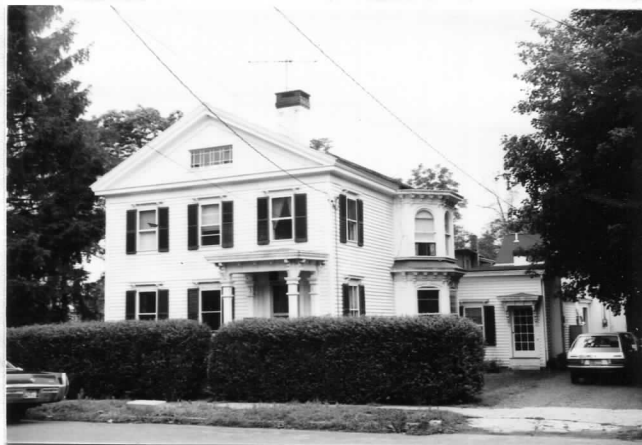
7. ALTERATIONS
 Rear wing appears to be a much later addition but perhaps re-uses an existing doorhood. For the rest, see below.

A classical Greek Revival house with its cornice drawn across the facade to form a pediment. Sometime around 1870, judging by appearances, the oversized porch and the octagonal bay on the east were added; the bracketed window hoods were probably also put on at this time: a style-conscious owner was evidently doing everything he could think of to spruce up an old-fashioned house. He allowed the Greek Revival window to remain in the gable. Well maintained and enlarged, this is a handsome property at the intersection of two of Guilford's most important streets.
