HISTORIC RESOURCES INVENTORY:
 Buildings & Structures

SURVEY OF GUILFORD, NEW HAVEN COUNTY, 06437

1. **ADDRESS** 105 Church Street
(map 46, lot 12)
2. **NAME**
(historic)
NAME
(common)
3. **USE**
(historic)
USE
(present) Private house and
apartments
4. **IF MOVED, WHEN AND FROM WHERE:**

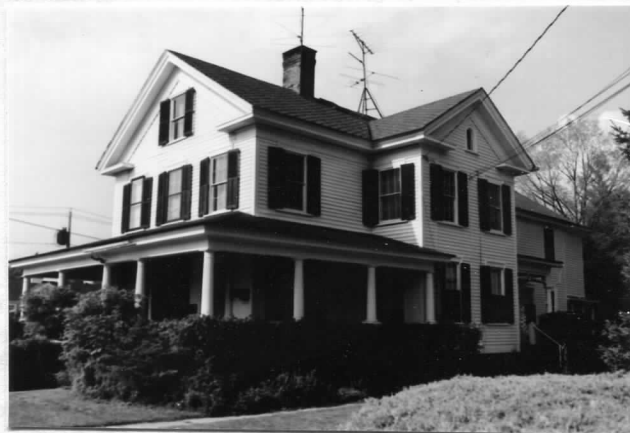
5. **ARCHITECT**
6. **DATE** Probably c1875 **BUILDER**
STYLE Greek Revival/Italianate
7. **ALTERATIONS**
The large wrap around Colonial Revival porch, which today dominates the design, was probably added around the turn of the century. Extension on rear, date unknown.
8. **NOTABLE FEATURES**
The shadow lines of the strongly projecting cornice and window frames, combined with the white columns and deep shade of the porch, make an interesting chiaroscuro on the whitewalls.
9. **ARCHITECTURAL-HISTORICAL**
Although the porch in current form is Colonial Revival, it follows the shape of an earlier porch which is apparent in the 1881 Birdseye view. The smaller porch at the rear perhaps retains the elements of the earlier front porch. This imposing house lends a strong residential presence to an area which is becoming increasingly commercial in nature.
