HISTORIC RESOURCES INVENTORY:
 Buildings & Structures

SURVEY OF GUILFORD, NEW HAVEN COUNTY, 06437
 June-December 1981

- 1. ADDRESS 226 Church Street
(map 46, lot 99)
- 2. NAME Daniel A. O'Neil
(historic)
NAME
(common)
- 3. USE
(historic)
USE
(present) Private house
- 4. IF MOVED, WHEN AND FROM WHERE:

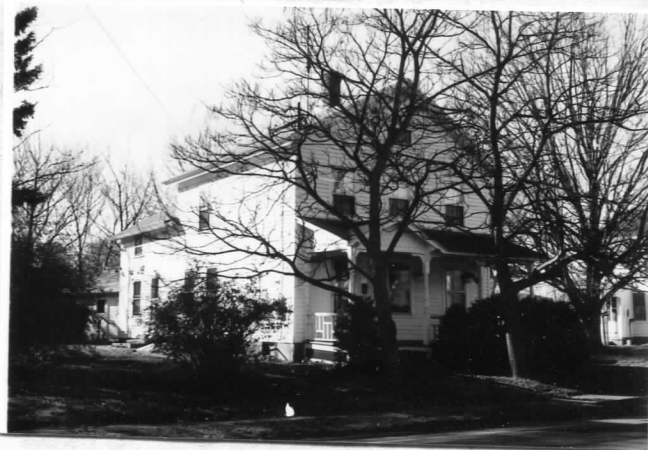
- 8. NOTABLE FEATURES
Porch with decorative post and fish scale shingles in the gable; gable window with three panes.
- 9. ARCHITECTURAL-HISTORICAL
One of a group of three houses that appears to have been built at the same time. This two-story house retains much of its original character. A gable was placed on the shed roof porch over the entry. Fish scale shingles decorate porch gable along with the boards at the porch ends. Small turned posts with brackets support the porch roof. The other two houses have been covered with synthetic siding and have had most of the architectural ornament removed.
