HISTORIC RESOURCES INVENTORY:
Buildings & Structures

SURVEY OF GUILFORD, NEW HAVEN COUNTY, 06437
June-December 1981

- ADDRESS** 385 Colonial Road
(map 4, lot 19)
- NAME** Dan L. Benton, Jr.
(historic)
NAME
(common)
- USE**
(historic)
USE
(present) Private house
- IF MOVED, WHEN AND FROM WHERE:**

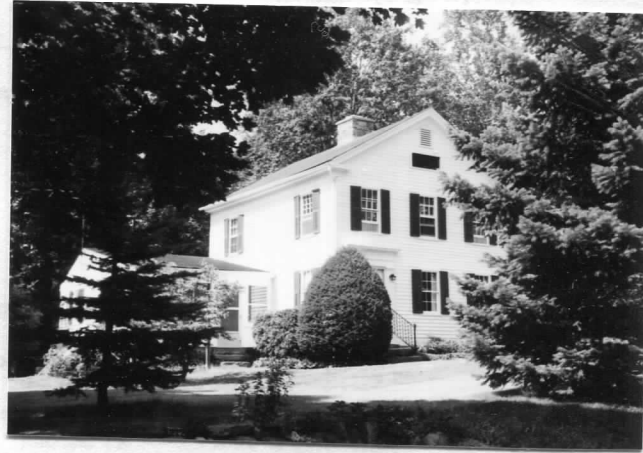
- ARCHITECT**
- DATE** 1839 **BUILDER**
STYLE Greek Revival
- ALTERATIONS**
Side addition; stone chimney (rebuilt); railing on front steps.

- NOTABLE FEATURES**
Boxed cornice with returns; frieze; 6/6 sash; rectangular gable window; doorway with pilasters and entablature.
- ARCHITECTURAL-HISTORICAL**
Modest cornice returns, a rectangular gable window, and a pilaster and entablature doorway along with a three bay facade are typical features of Greek Revival house in Guilford. Fairly large barn/garage located to the right of the house close to the road.
Dan L. Benton, Jr. built this house on 18 acres, which were formerly Pelatiah Leete's "Hart Lot" which his grandfather - Silas Benton - had bought in 1801. Dan Benton had extensive land holdings on Sachem's Head.
