HISTORIC RESOURCES INVENTORY:
 Buildings & Structures

SURVEY OF GUILFORD, NEW HAVEN COUNTY, 06437
 June-December 1981

1. **ADDRESS** 1092 Durham Road
 (map 91, lot 47)
2. **NAME**
(historic) Rebuzzini Barn
NAME
(common)
3. **USE**
(historic) Barn
USE
(present) Barn
4. **IF MOVED, WHEN AND FROM WHERE:**

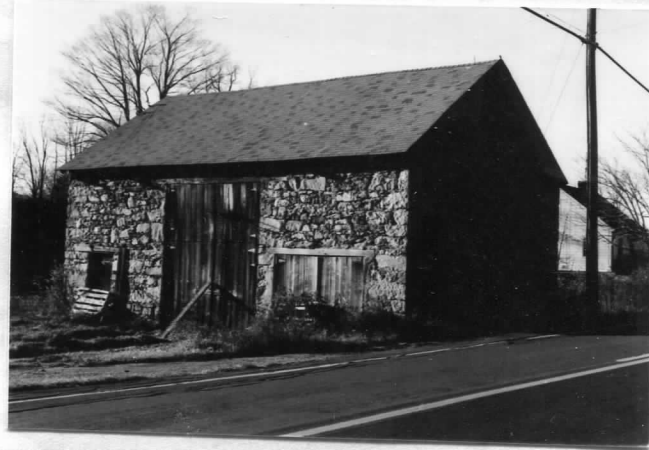
5. **ARCHITECT**
6. **DATE** c1914
- BUILDER** John Rebuzzini
STYLE
7. **ALTERATIONS**
 Asphalt roofing.
8. **NOTABLE FEATURES**
 Uncoursed ashlar and rubble.

A landmark on the Durham Road, this stone barn is a striking feat of masonry, its sheer planes built of uncoursed rubble with huge quoins of irregular shape and with voussoirs over some (not all) of the windows. This barn was built by John Rebuzzini, an Italian from Bergamo, who came to Killingworth about 1900 and later to Guilford. Two barns which stood on opposite sides of the road burned down 4 July 1913 - the Rebuzzini's later sold the farm to Charles Monte who ran a poultry business here for 40 years.
