HISTORIC RESOURCES INVENTORY:
 Buildings & Structures

SURVEY OF GUILFORD, NEW HAVEN COUNTY, 06437
 June-December 1981

1. **ADDRESS** 55 Graves Avenue
(map 40, lot 32)
2. **NAME**
(historic) Fannie E. White
NAME
(common)
3. **USE**
(historic)
USE
(present) Private house
4. **IF MOVED, WHEN AND FROM WHERE:**

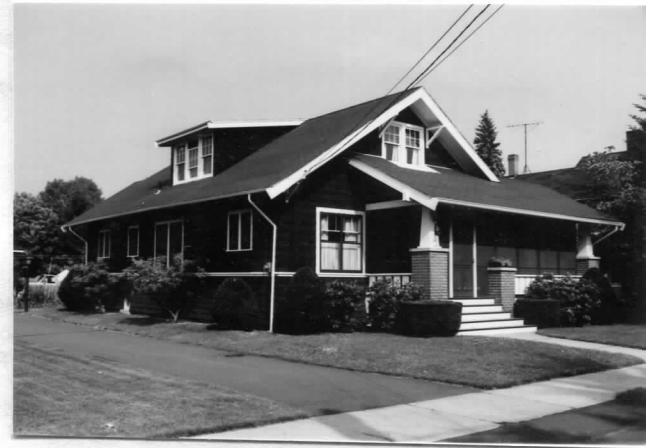
5. **ARCHITECT**
6. **DATE** c1926 **BUILDER**
STYLE Bungalow
7. **ALTERATIONS** Brick columns on porch, screened in porch.

8. **NOTABLE FEATURES**
Overhanging eaves with rafters visible and brackets; flat boards for the bargeboards; 6/1 sash.

9. **ARCHITECTURAL-HISTORICAL**
One of the few bungalows in Guilford this one and a half-story house is a good example of the style. The gable roof faces the street with large functional looking brackets placed under eaves. A shed roof porch has brick and battered wooden piers, is set off center from the main portion of the house. The use of shed dormers and the 6/1 sash are features that are typical of the Bungalow style.
