HISTORIC RESOURCES INVENTORY:
 Buildings & Structures

SURVEY OF GUILFORD, NEW HAVEN COUNTY, 06437
 June-December 1981

1. **ADDRESS** 50 Ledge Hill Road
(map 108, lot 28)
2. **NAME**
(historic) St. John's Episcopal Church
NAME
(common) Parsonage
3. **USE**
(historic)
USE
(present) Private house
4. **IF MOVED, WHEN AND FROM WHERE:**

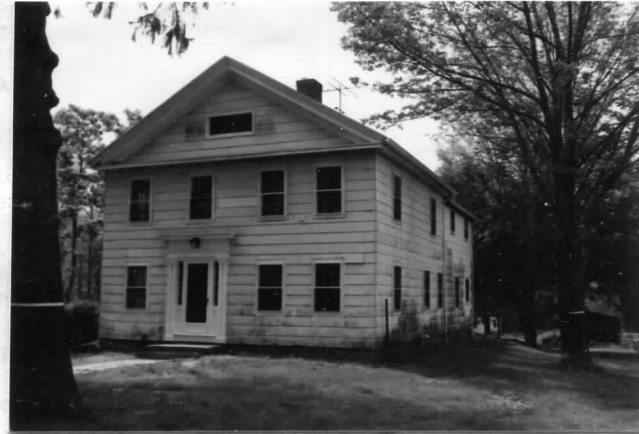
8. **NOTABLE FEATURES**
Four bay facade; boxed cornice (pedimented); 6/6 sash; Greek Revival doorway with an entablature; recessed panels, pilasters, and sidelights.
9. **ARCHITECTURAL-HISTORICAL** The wide doorway with sidelights and paneled pilasters is appropriate for the four-bay width of this building. Its proportions are more substantial than other Greek Revival houses in the area, almost all of which are three bays wide. In appearance it seems earlier than 1870.
 The house was built by St. John's Church, it is believed, c1870 to replace an earlier parsonage (built c1830-40) which had burned down. The Rev. Jepson was the first pastor to live here. In the period, 1900-1910, a part of the building served as a North Guilford primary school. The Church sold the property in 1940-41. It has been a private house ever since.

- Excellent Good Fair *in process of renovation* Poor Bad
