HISTORIC RESOURCES INVENTORY:
 Buildings & Structures

SURVEY OF GUILFORD, NEW HAVEN COUNTY, 06437
 June-December 1981

1. **ADDRESS** 715 Leete's Island Road
(map 18, lot 17)
2. **NAME**
(historic) Daniel and Charity Leete
NAME
(common)
3. **USE**
(historic)
USE
(present) Private house
4. **IF MOVED, WHEN AND FROM WHERE:**

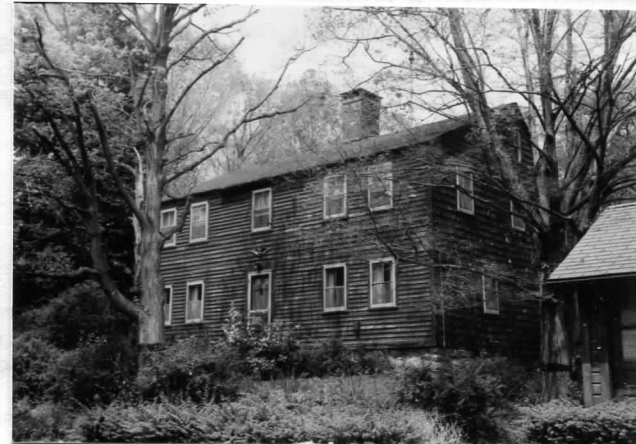
5. **ARCHITECT**
6. **DATE** 1784 **BUILDER STYLE** Colonial
7. **ALTERATIONS**
 Shingle siding on the sides; 2/2 windows; chimney (rebuilt); roof line altered.
8. **NOTABLE FEATURES**
 Plain window and door frames; stone foundation.
