HISTORIC RESOURCES INVENTORY:
 Buildings & Structures

SURVEY OF GUILFORD, NEW HAVEN COUNTY, 06437
 June-December 1981

1. **ADDRESS** 988 Leete's Island Road
2. **NAME** (map 18, lot 1)
(historic) Henry W. Norton
NAME *(common)*
3. **USE** *(historic)*
USE *(present)* Private house
4. **IF MOVED, WHEN AND FROM WHERE:**

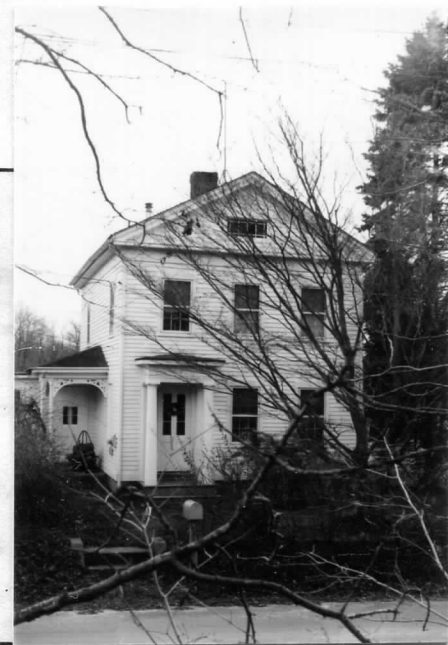
Negative 21:35

5. **ARCHITECT**
6. **DATE** 1851 **BUILDER STYLE** Greek Revival
7. **ALTERATIONS**
 Side entrance porch trim.

8. **NOTABLE FEATURES**
 Boxed cornice (pedimented); frieze; rectangular gable window; 6/6 sash; wide wood lintels; entrance portico with fluted columns and an entablature. Interior - Wooster Square mantel in parlor.
9. **ARCHITECTURAL-HISTORICAL**
 This house is unusual in having a portico with columns instead of the pilaster and entablature entry commonly found in the town's Greek Revival buildings. An entrance porch at the side has elaborate scroll work of the later 19th century.
 Henry Norton, the house's first owner, married Amelia C. Leete on September 18, 1850. He built this house while the New Haven and New London Railway Company was laying the track nearby in 1851.
