HISTORIC RESOURCES INVENTORY - BUILDING AND STRUCTURES

Building Name (Common) 43 South Fair Street
 Building Name (Historic) Frank D. Spencer House
 Street Address or Location 43 South Fair Street
 Town/City Guilford Village _____ County New Haven
 Owner(s) Marco and Helen Rizzo Public Private

Style of building Queen Anne Date of Construction 1911 (Helander)

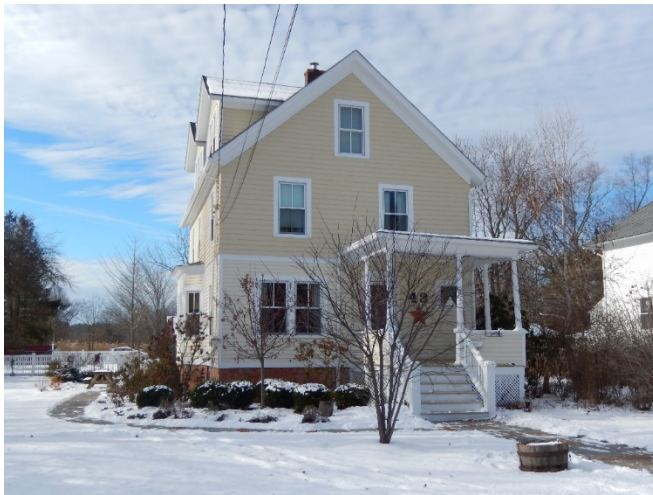
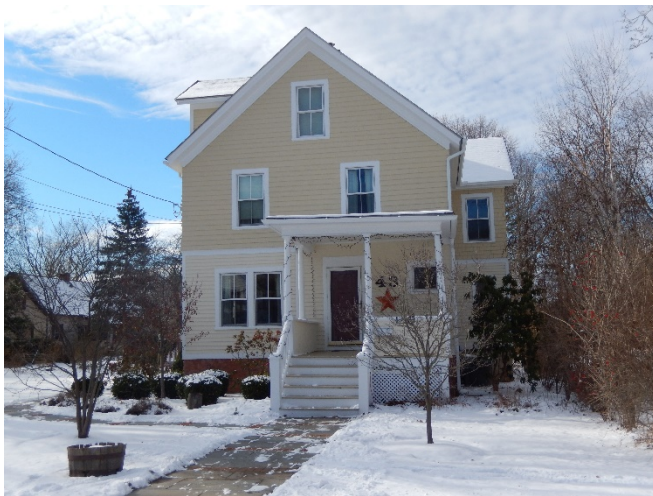
Photographer Jordan Sorensen Date 01/11/2015
View Northeast, camera facing southwest Negative on File _____
Name Jordan Sorensen Date 09/27/2015
Organization Guilford Preservation Alliance
Address PO Box 199 Guilford, CT 06437
