HISTORIC RESOURCES INVENTORY:
Buildings & Structures

SURVEY OF GUILFORD, NEW HAVEN COUNTY, 06437
June-December 1981

1. ADDRESS 94 State Street
(map 46, lot 5)
2. NAME
(historic) Ambrose Benton
NAME
(common)
3. USE
(historic)
USE
(present) Private house
4. IF MOVED, WHEN AND FROM WHERE:

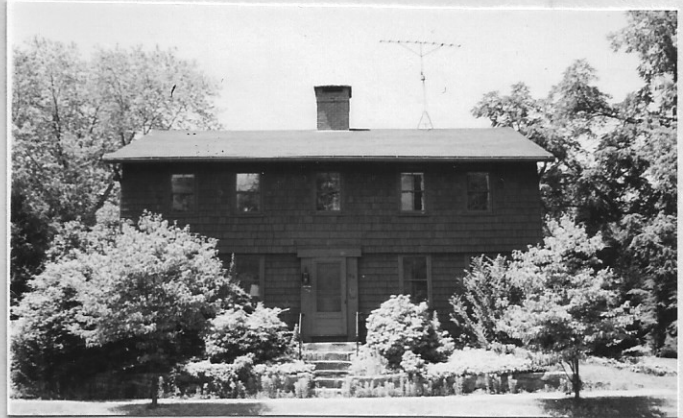
5. ARCHITECT
6. DATE 1798 BUILDER
STYLE Colonial
7. ALTERATIONS
Red-painted shingles; 2/2 sash; side porch and rear shed.
For major changes see below.
8. NOTABLE FEATURES

9. ARCHITECTURAL-HISTORICAL
Like 15 State Street, this was a late 18th century one-story house before the 20th century's demand for more space urged owners to add a second floor. The roof slope belongs to the 20th century but the second-floor overhang and central chimney give an 18th century aspect to this house. The interior still has some important original work.
