HISTORIC RESOURCES INVENTORY:
 Buildings & Structures

SURVEY OF GUILFORD, NEW HAVEN COUNTY, 06437
 June-December 1981

1. **ADDRESS** 1315 Boston Post Road
(map 45, lot 13)
2. **NAME**
(historic)
NAME
(common)
3. **USE**
(historic)
USE
(present) Private house until 1982
(see below)
4. **IF MOVED, WHEN AND FROM WHERE:**

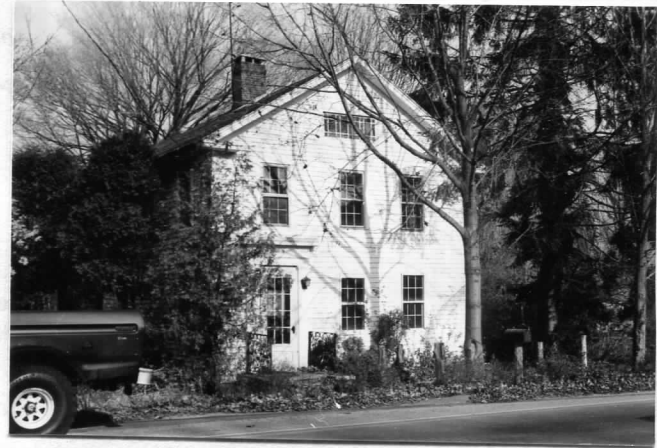
The glazed front door is evidently a later addition. It relates well to the 6/6 sash and adds to the facade's slender verticality.

8. **NOTABLE FEATURES** The cast iron railings on the front steps, probably added later in the 19th century, are distinguished-- unlike others now known in Guilford or New Haven. Also note the design of the gable window, an elegant elaboration of the usual Greek Revival corner-crossed muntins.

An unpretentious but charming small house, enhanced by a large lot with rolling terrain and a dense growth of trees. As this survey goes to press, the house is being remodeled for a funeral home with the addition of a new wing on the west side, aluminum siding and a parking lot, which will considerably alter the character of its impact on the scenery of the roadside.
