**HISTORIC RESOURCES INVENTORY:**  
 Buildings & Structures

**SURVEY OF GUILFORD, NEW HAVEN COUNTY, 06437**  
 June-December 1981

1. **ADDRESS** 1350 Boston Post Road  
 (map 45, lot 9)
2. **NAME**  
 (historic)  
**NAME**  
 (common)
3. **USE**  
 (historic)  
**USE**  
 (present) Private house
4. **IF MOVED, WHEN AND FROM WHERE:**

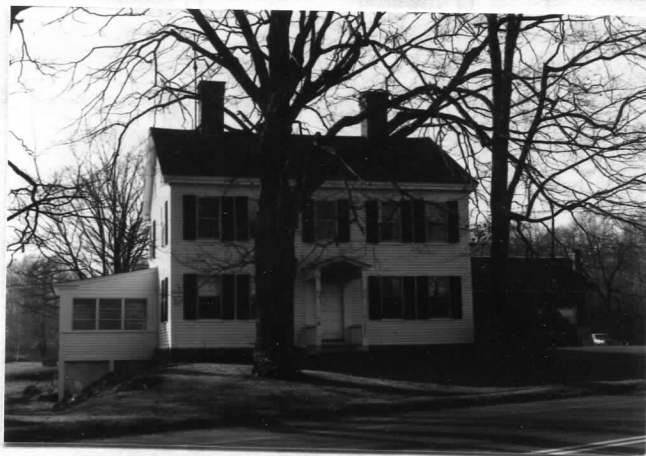
5. **ARCHITECT**
6. **DATE** Probably c1820 **BUILDER** Federal  
**STYLE**
7. **ALTERATIONS**  
 East and rear wings added. The posts of the entry porch are Queen Anne; possibly the roof is original.

8. **NOTABLE FEATURES**  
 This house looks particularly well in its setting, on ample grounds with big trees and with barns out back. Combined with Bishop's big farm market across the street, it gives this brief stretch of the Post Road a special accent.
9. **ARCHITECTURAL-HISTORICAL**  
 A typical Federal house, with tall paired chimneys and a pretty fanlight over the door. Inside, the central hall plan has been altered, but much original work remains--doors, mantels, chair rails. Barns out back.  
 Located across the road from Bishop's barn, orchards, and stand, this is the farmhouse to which the original Bishop farm belonged. It was lived in by Walter Bishop next by his son, Burton, and now by the widow of Burton's son Charles. See 1355 Boston Post Road.
