HISTORIC RESOURCES INVENTORY:
 Buildings & Structures

SURVEY OF GUILFORD, NEW HAVEN COUNTY, 06437
 June-December 1981

1. **ADDRESS** 121 Boston Street
 (map 40, lot 41)
2. **NAME**
(historic) John Chittenden
NAME
(common)
3. **USE**
(historic)
USE
(present) Private house
4. **IF MOVED, WHEN AND FROM WHERE:**

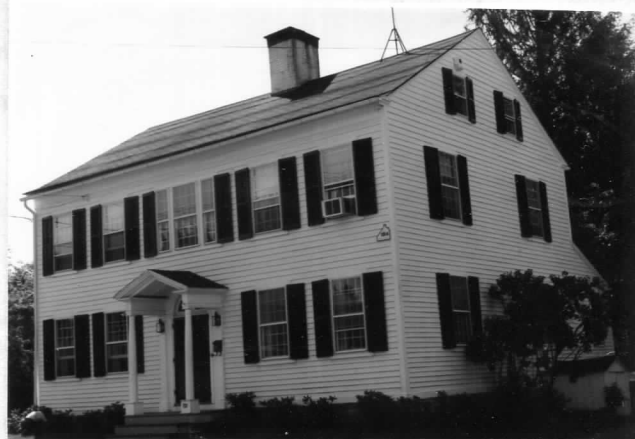
8. **NOTABLE FEATURES**
 The triple central window was a gesture of elegance in Federal Guilford. This is one of half a dozen or so in town.
9. **ARCHITECTURAL-HISTORICAL**
 A nicely-detailed house that has been well preserved. The porch and leaded fanlight are Late 18th century in form, simple but delicate in scale. 12/12 sash enhances the overall crispness. The house is said to have a secret compartment under the floor of a closet, but history unfortunately does not record who or what was hidden there. John B. Chittenden, son of Abraham Chittenden, was a deacon of the First Church. He moved to Illinois not long after building his house.
