# HISTORIC RESOURCES INVENTORY - BUILDING AND STRUCTURES

Building Name (Common) 131 Boston Street  
 Building Name (Historic) William Blatchley House  
 Street Address or Location 131 Boston Street  
 Town/City Guilford Village \_\_\_\_\_ County New Haven  
 Owner(s) Russell Campaigne and Mary Jo Kestner  Public  Private

**131 Boston Street**

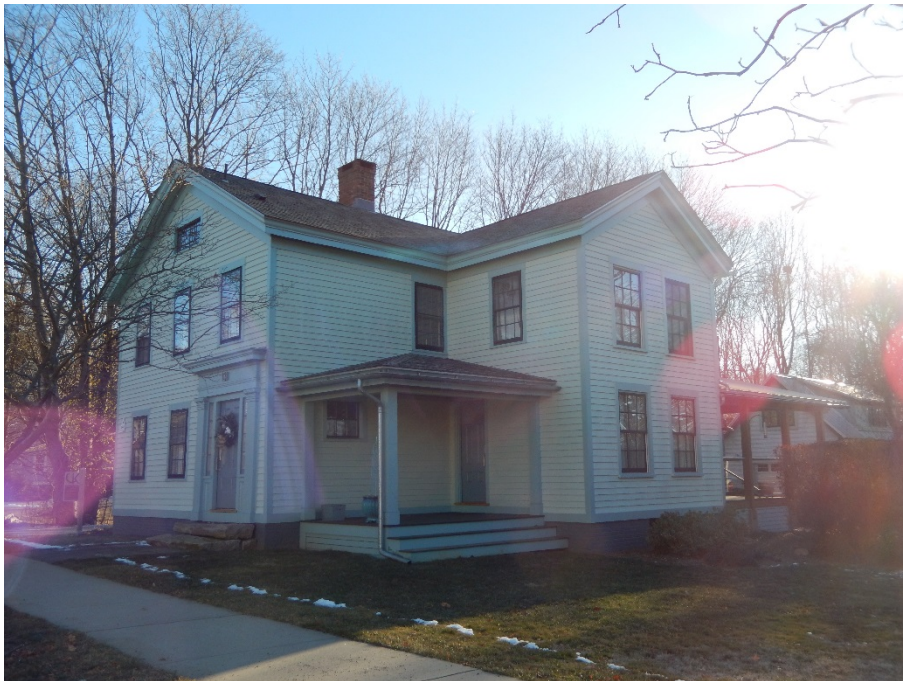
View Northwest view, camera facing southeast. Negative on File \_\_\_\_\_
