**HISTORIC RESOURCES INVENTORY:**  
 Buildings & Structures

**SURVEY OF GUILFORD, NEW HAVEN COUNTY, 06437**  
 June-December 1981

1. ADDRESS 150 Boston Street  
(map 40, lot 64)
2. NAME  
(historic) Thomas Burgis  
NAME  
(common)
3. USE  
(historic)  
USE  
(present) Private house and doctor's office
4. IF MOVED, WHEN AND FROM WHERE:

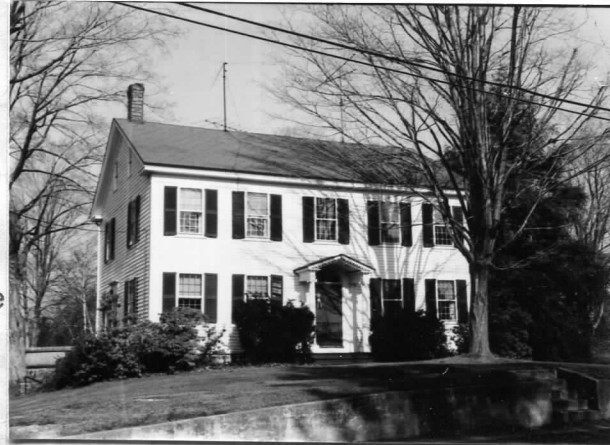
One of Guilford's most elegant Federal doorways, with dainty fluted Ionic columns and a pretty leaded fanlight.
