HISTORIC RESOURCES INVENTORY:
 Buildings & Structures

SURVEY OF GUILFORD, NEW HAVEN COUNTY, 06437
 June-December 1981

1. ADDRESS 96 Church Street
(map 46, lot 22)
2. NAME
(historic)
NAME
(common)
3. USE
(historic)
USE
(present) Private house
4. IF MOVED, WHEN AND FROM WHERE:

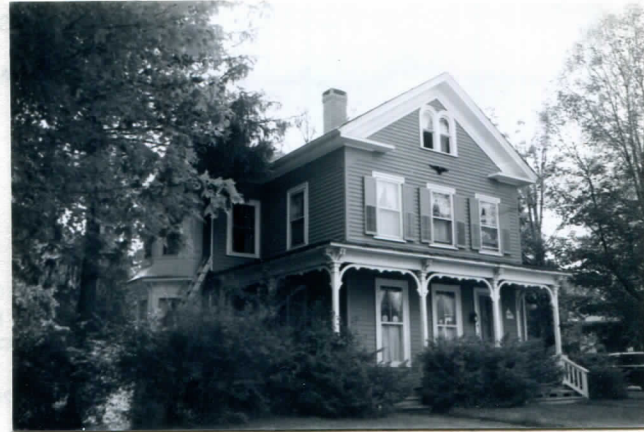
8. NOTABLE FEATURES
Boxed cornice with returns; frieze and below, at the corners are flat boards resembling brackets; double sash windows in the gable; two over two windows with a moulding around the window frame; two story bay window on side; arched staircase window with stainglass; decorative
9. ARCHITECTURAL-HISTORICAL wrap around porch with brackets above the posts.
