HISTORIC RESOURCES INVENTORY:
Buildings & Structures

SURVEY OF GUILFORD, NEW HAVEN COUNTY, 06437
June-December 1981

1. ADDRESS 148 Clapboard Hill Road
(map 75, lot 15)
2. NAME
(historic) Clapboard Hill Schoolhouse
NAME
(common)
3. USE
(historic) One room school - 1835-1931
USE
(present) Idle
4. IF MOVED, WHEN AND FROM WHERE:
See below

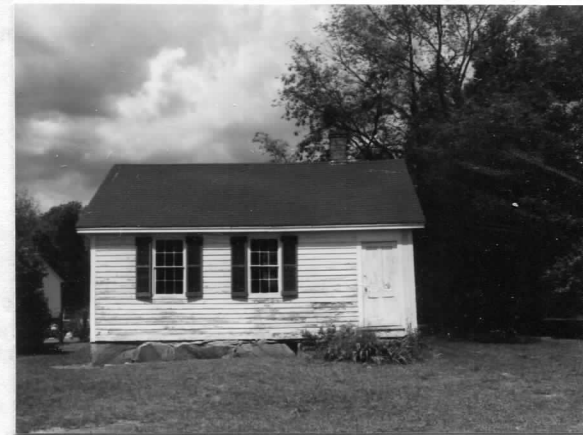
5. ARCHITECT
6. DATE 1835
- BUILDER
STYLE Late Colonial Vernacular
7. ALTERATIONS
Originally painted white - then red for a brief period in the 20th century, it is now white.
8. NOTABLE FEATURES
Overhanging eaves; boxed cornice; frieze; 6/6 sash; large rocks for the foundation.
9. ARCHITECTURAL-HISTORICAL
Originally built on the corner of Goose Lane and Clapboard Hill, it was moved to the top of the hill in 1851 and then moved again the following year to its present site. Students attended this school from 1835 until 1931 when the consolidation of several schools brought about its closing. It is now private property. Its story has been written by Joel E. Helander, cf - ref.
