HISTORIC RESOURCES INVENTORY:
 Buildings & Structures

SURVEY OF GUILFORD, NEW HAVEN COUNTY, 06437
 June-December 1981

- 1. **ADDRESS** 384 Clapboard Hill Road
(map 81, lot 26)
- 2. **NAME** Henry Dudley
(historic)
NAME
(common)
- 3. **USE**
(historic)
USE Private house
(present)
- 4. **IF MOVED, WHEN AND FROM WHERE:**

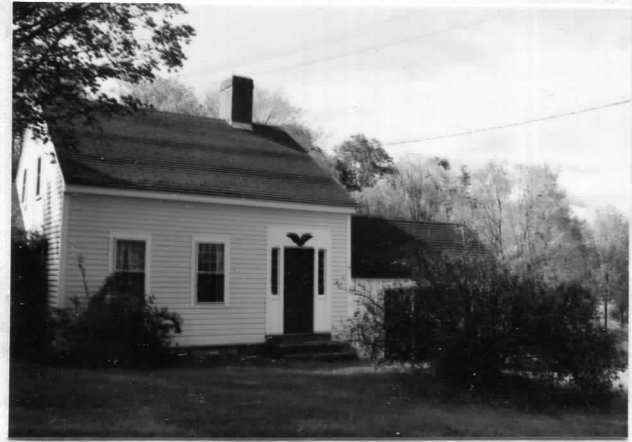
- 5. **ARCHITECT**
- 6. **DATE** 1829 **BUILDER**
STYLE Federal
- 7. **ALTERATIONS**
Side and rear additions. Doorway appears to be modern.
- 8. **NOTABLE FEATURES**
Twelve over twelve sash, six over six sash in gable; stone slab foundation.
- 9. **ARCHITECTURAL-HISTORICAL**
This small house was built a decade or so before the many Greek Revival houses were built in this area. It is a simple story and a half house that may have had another type of doorway at one time.
