HISTORIC RESOURCES INVENTORY:
 Buildings & Structures

SURVEY OF GUILFORD, NEW HAVEN COUNTY, 06437
 June-December 1981

1. **ADDRESS** 376 Colonial Road
(map 4, lot 25)
2. **NAME**
(historic) Eli Kircum
NAME
(common)
3. **USE**
(historic) Toll House
USE
(present) Private house
4. **IF MOVED, WHEN AND FROM WHERE:**

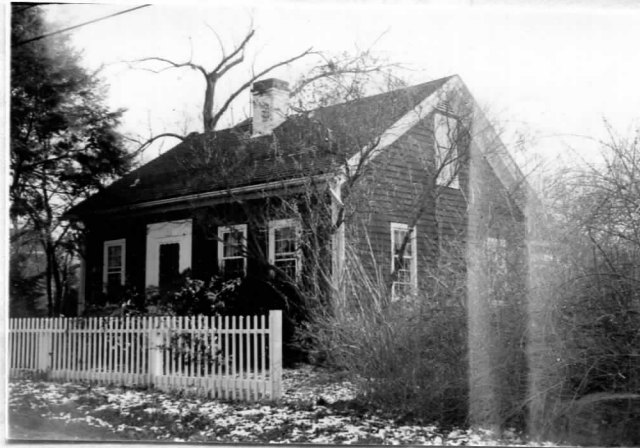
GLFD's NEG 21:28

5. **ARCHITECT**
6. **DATE** 1824 **BUILDER STYLE** Federal
7. **ALTERATIONS**
Rear porch; excavated around cellar in rear.

8. **NOTABLE FEATURES**
Boxed cornice; frieze; 6/9 sash; plain door frame; stone central chimney; stone foundation.
9. **ARCHITECTURAL-HISTORICAL**
This simple house was built close to the road so that the owner could operate the toll gate. It is interesting that despite its practical purpose the house contains heavy decorative cornices on the gable ends. The house is very small in size and is nicely set off by a picket fence in scale. The door and door frame appear to be modern.
