HISTORIC RESOURCES INVENTORY:
Buildings & Structures

SURVEY OF GUILFORD, NEW HAVEN COUNTY, 06437
June-December 1981

1. ADDRESS 470 County Road
(map 104, lot 39)
2. NAME
(historic) Dr. David Brook's Coachman's
NAME House
(common)
3. USE
(historic) Coachman's house
USE
(present) Private house
4. IF MOVED, WHEN AND FROM WHERE: The house was
moved in 1832 from the Brook's property
on Long Hill Road

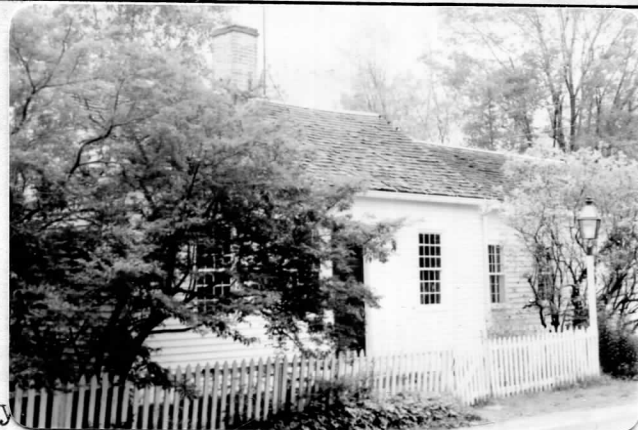
5. ARCHITECT
6. DATE 1770 BUILDER
STYLE Colonial
7. ALTERATIONS
Side addition for kitchen; brick chimney
8. NOTABLE FEATURES
12/12 sash; simple moulding around windows and door; door and
window sharing common jamb; plank house.

This small house built to house a coachman, possibly a slave, is understandably simple. However, in its simplicity there is great charm. The house has been carefully restored and the addition does not detract from the original.

15. CONDITION: Exterior

☒ Good
