HISTORIC RESOURCES INVENTORY:
 Buildings & Structures

SURVEY OF GUILFORD, NEW HAVEN COUNTY, 06437
 June-December 1981

- ADDRESS** 27 Graves Avenue
(map 40, lot 36)
- NAME**
(historic)
NAME
(common)
- USE**
(historic)
USE
(present) Private house
- IF MOVED, WHEN AND FROM WHERE:**

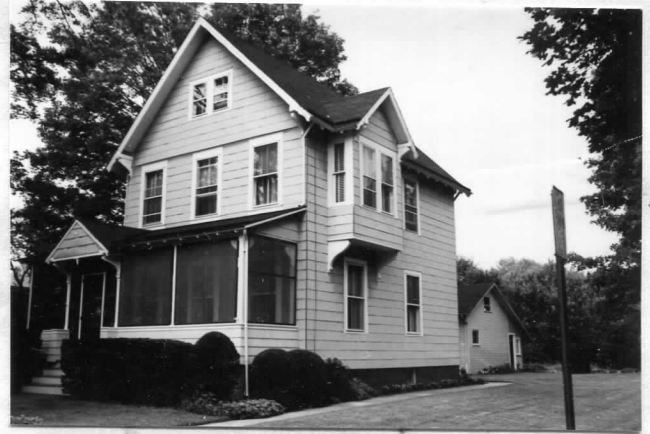
- ARCHITECT**
- DATE** c1888 **BUILDER STYLE** Queen Anne
- ALTERATIONS**
Siding; screened in porch.

- NOTABLE FEATURES**
Wide eaves with visible rafters; modest decorated bargeboards; rectangular second story bay with brackets similar to the brackets under the eaves; brick foundation.
- ARCHITECTURAL-HISTORICAL**
Exposed rafters, brackets, and an overhanging bay are features that contribute to the picturesque nature of this house of the Queen Anne style. Houses of that style usually had decoratively cut wooden shingles adding a variety of textures; here siding hides or replaces them.
