HISTORIC RESOURCES INVENTORY - BUILDING AND STRUCTURES

| GENERAL INFORM | | | | | | |
|---|--|---|---|---|---|---|
| Building Name (Comme | on) 538 Long Hill Roa | d | | | | |
| Building Name (Histori | c) Edmund Page Hous | se | | | | |
| Style of building Greek | yle of building Greek Revival Date of Construction 1842 (Helander) | | | | | ander) |

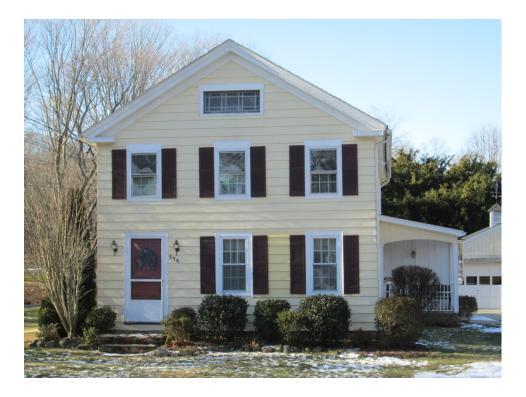
| Photographer Kristen Nietering | | | Date 1/21/2015 | | |
|---|---|---|---|---|--|
| View East view of the house, camera facing southwest. | | | Negative on File | | |
