HISTORIC RESOURCES INVENTORY:
 Buildings & Structures

SURVEY OF GUILFORD, NEW HAVEN COUNTY, 06437
 June-December 1981

1. **ADDRESS** 85 Long Hill Road
 (map 45, lot 16)
2. **NAME**
(historic)
NAME
(common)
3. **USE**
(historic)
USE
(present) Private house
4. **IF MOVED, WHEN AND FROM WHERE:**

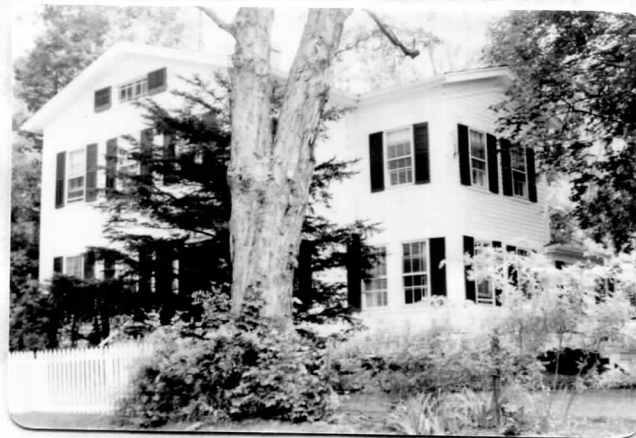
5. **ARCHITECT**
6. **DATE** c1855 **BUILDER** Greek Revival
STYLE
7. **ALTERATIONS**
 Side wing; screened porch in rear.

8. **NOTABLE FEATURES**
 Frieze; 6/6 sash; rectangular gable window with decorative muntins; wide lintel boards over window openings; doorway with recessed panel pilasters and an entablature.
9. **ARCHITECTURAL-HISTORICAL**
 The rather low pitch of the roof and a cornice with neither a pediment nor returns make this an unusual house for the Greek Revival style. Nonetheless, it possessed features that tie it firmly to Guilford's family of houses of that style, including the decorative rectangular gable window and entablature of the doorway. With its picket fence and shady side yard, it is a valuable part of the street.
 This property's owner is identified as E. Eggleston on the 1856 Map. In 1868, S. Griffin was indicated as its owner on the map of that date. No further data on either person has been found to date.
