HISTORIC RESOURCES INVENTORY:
 Buildings & Structures

SURVEY OF GUILFORD, NEW HAVEN COUNTY, 06437
 June-December 1981

1. ADDRESS 136 Prospect Avenue
(map 1, lot 16)
2. NAME
(historic) Herbert S. Baker
NAME
(common)
3. USE
(historic)
USE
(present) Private house
4. IF MOVED, WHEN AND FROM WHERE:

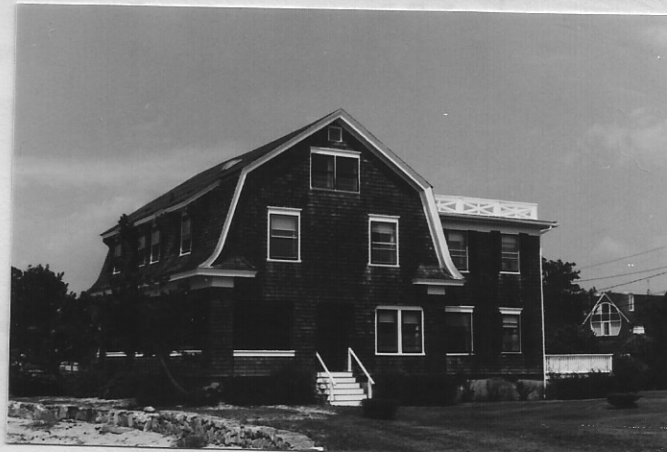
5. ARCHITECT
6. DATE 1907
- BUILDER
STYLE Shingle/ Colonial Revival
7. ALTERATIONS
Rear portion (flat roof) added later.
8. NOTABLE FEATURES
Gambrel roof boxed cornice with returns; frieze; shed roof dormers; moulding above the windows; veranda; balustrade on the flat roof of the rear of the house.

9. ARCHITECTURAL-HISTORICAL
The large shingle-covered columns of this house provide solid support for an overhanging second floor that shelters a porch on the water side, a very successful integration of a porch into the basic shape of the structure. The upper slope of the gambrel roof extends to provide shed roofs for second story dormers. This is a handsome example of a Colonial Revival house built for the living at the sea shore.
