HISTORIC RESOURCES INVENTORY - BUILDING AND STRUCTURES

Building Name (Common) 105 Union Street
 Building Name (Historic) Calvin H. Norton House
 Street Address or Location 105 Union Street
 Town/City Guilford Village _____ County New Haven
 Owner(s) Eric and Alexandra Dufresne Public Private

Style of building Greek Revival Date of Construction 1878 (Helander)

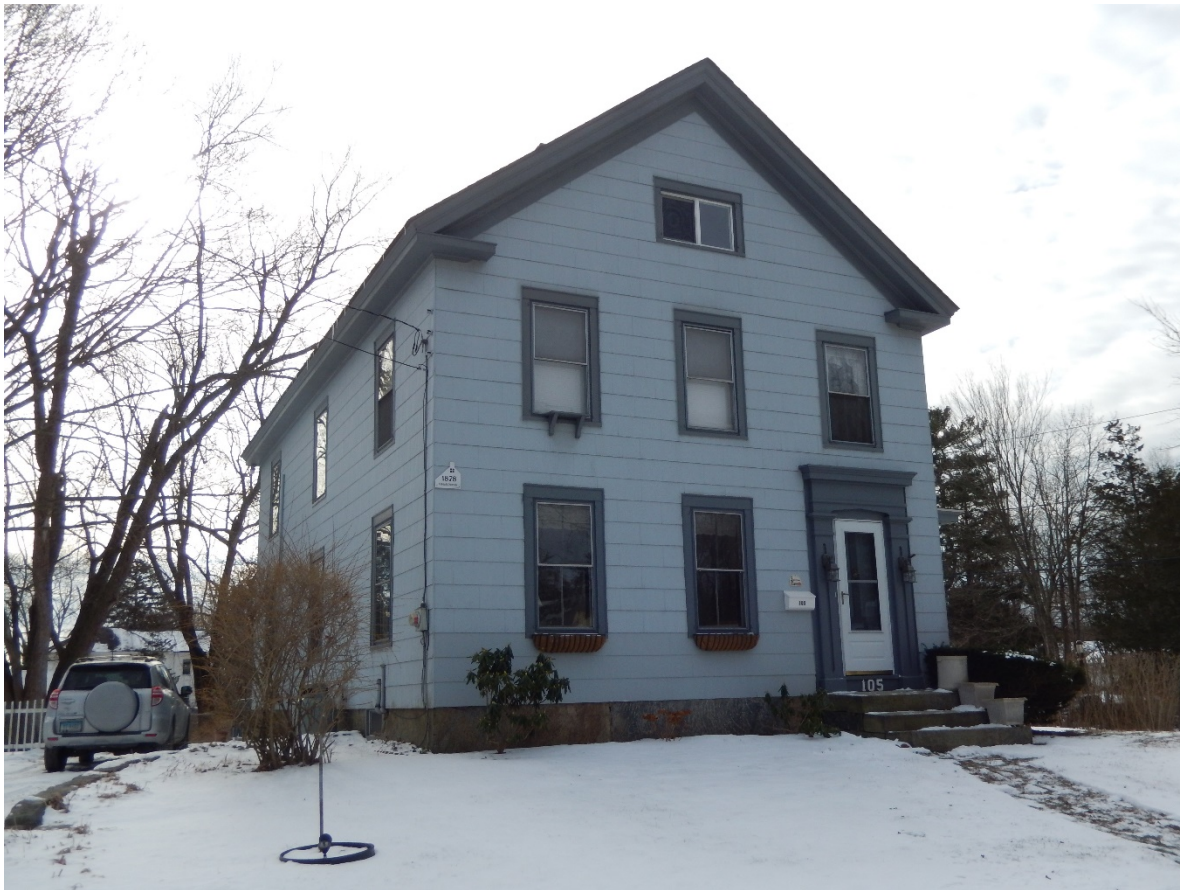
Photographer Jordan Sorensen Date 01/11/2015
View North, camera facing south Negative on File _____
Name Jordan Sorensen Date 08/13/2015
Organization Guilford Preservation Alliance
Address PO Box 199 Guilford, CT 06437
