HISTORIC RESOURCES INVENTORY - BUILDING AND STRUCTURES

Building Name (Common) 1 Whitfield Street
 Building Name (Historic) Lydia Chittenden House
 Street Address or Location 1 Whitfield Street
 Town/City Guilford Village _____ County New Haven
 Owner(s) Lee Leighton III Public Private

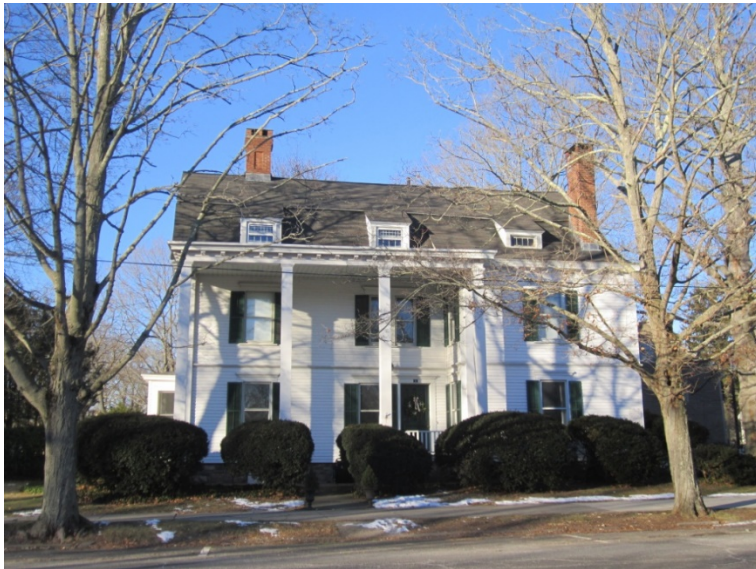
Photographer Jordan Sorensen Date 1/17/2015
View East view of building, camera facing west Negative on File _____
Name Jordan Sorensen Date 2/16/2015
Organization Guilford Preservation Alliance
Address PO Box 199 Guilford, CT 06437
