HISTORIC RESOURCES INVENTORY:
Buildings & Structures

SURVEY OF GUILFORD, NEW HAVEN COUNTY, 06437
June-December 1981

1. ADDRESS ²¹¹ ~~210~~ Beaver Head Road
(map 112, lot 14)
2. NAME
(historic)
NAME
(common)
3. USE
(historic)
USE
(present) Private house and farm
4. IF MOVED, WHEN AND FROM WHERE:

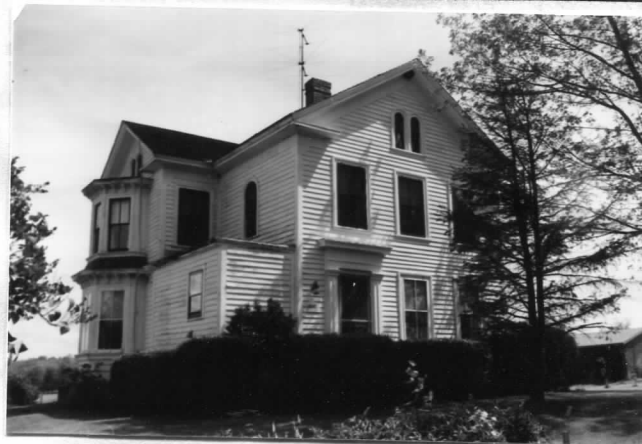
5. ARCHITECT
6. DATE Probably c1870
- BUILDER
STYLE Italianate
7. ALTERATIONS West porch now enclosed, but an added porch on the east side may show a re-use of original arcade. Rear wing added.

8. NOTABLE FEATURES This house and No. 154 are almost identical. Tall, solid, and comfortable; standing up on their high windy ridge in the midst of some of Guilford's most beautiful remaining country, and still surrounded by barns and the long open slopes of field and pasture, they give us a picture of the prosperous North Guilford farmer in the

9. ARCHITECTURAL-HISTORICAL period after the Civil War. Although the design is typical of the Italianate style (cross-dows for accents in key places), the doorway still belongs to the Greek Revival. Probably this reflects the mixture of fashion and die-hard tradition that characterizes so much of the town's rural architecture. The two-tiered octagonal bay window and its ruffle of brackets add still a newer note, doubtless the last word in their day. On No. 154 the pierced work in the spandrels of the porch arcade give a nice airy touch. Both houses have foundations of red sandstone ashlar--a sign of the affluence of the times and the march of technology and production.
