HISTORIC RESOURCES INVENTORY:
Buildings & Structures

SURVEY OF GUILFORD, NEW HAVEN COUNTY, 06437
June-December 1981

1. ADDRESS 1090 Boston Post Road
(map 46, lot 39)
2. NAME
(historic) Edwin A. Leete
NAME
(common) Ahlberg Antiques
3. USE
(historic) Cabinet making shop
USE
(present) Furniture repair shop
4. IF MOVED, WHEN AND FROM WHERE:

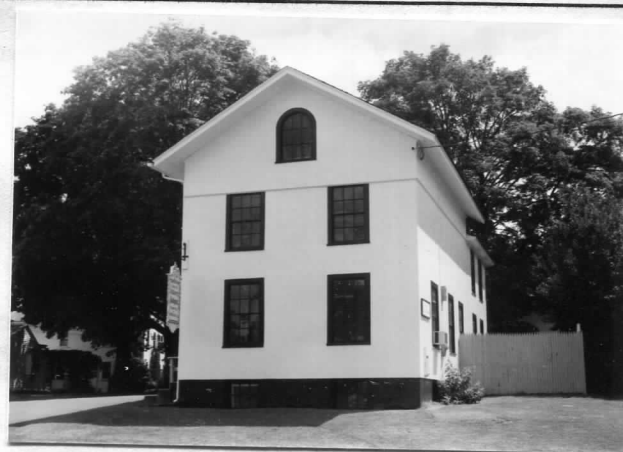
8. NOTABLE FEATURES A unique and vivid building, the clarity of the strong geometric form and the jutting overhang of the roof emphasized by the smooth flushboarding of the walls and by spanning white paint and dark green trim. The overhanging eaves and arched gable window suggest at first glance the Italianate style. But the two-bay facade is unexpected, and the wide arched window is not really Italianate. Is it possible that the building began as a barn or warehouse with a hoist in the gable window? Or is this an example of spontaneous vernacular design? In any case, it is a famous local landmark and an arresting sight amid the clutter of the Post Road.
