HISTORIC RESOURCES INVENTORY:
 Buildings & Structures

SURVEY OF GUILFORD, NEW HAVEN COUNTY, 06437
 June-December 1981

1. **ADDRESS** 1110 Boston Post Road
(map 46, lot 41)
2. **NAME** Parmelee House
(historic)
NAME Advest
(common)
3. **USE** House
(historic)
USE Office
(present)
4. **IF MOVED, WHEN AND FROM WHERE:** Moved from
the West side of River Street

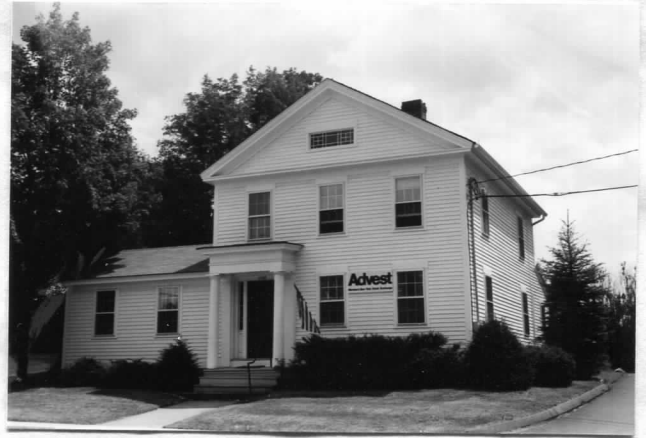
5. **ARCHITECT**
6. **DATE** 1840 **BUILDER**
STYLE Greek Revival
7. **ALTERATIONS**
East wing and porch railing modern.
8. **NOTABLE FEATURES**

9. **ARCHITECTURAL-HISTORICAL**
 With its gable end to the street, flat lintel boards, and main cornice drawn across the facade to suggest a classical pediment, this house is typical of the Greek Revival in Guilford. The owner indulged himself in a special flourish with the Doric porch and the elaborate pattern of muntins in the gable window.
