HISTORIC RESOURCES INVENTORY:
 Buildings & Structures

SURVEY OF GUILFORD, NEW HAVEN COUNTY, 06437
 June-December 1981

1. **ADDRESS** 1161 Boston Post Road
 (map 46, lot 56)
2. **NAME**
(historic) Nathaniel Cruttenden
NAME
(common)
3. **USE**
(historic)
USE
(present) Private house, apartments
4. **IF MOVED, WHEN AND FROM WHERE:**

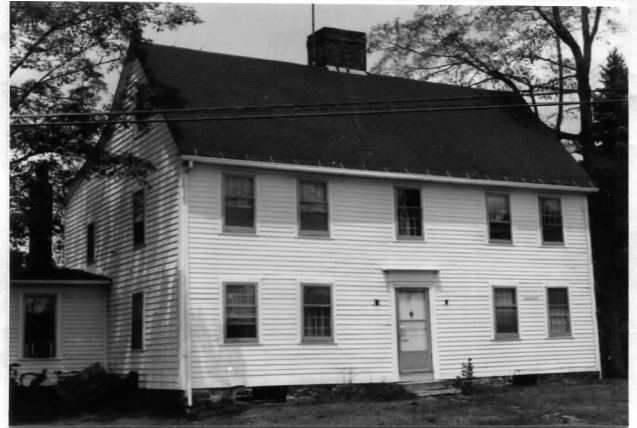
5. **ARCHITECT**
6. **DATE** 1752 **BUILDER**
STYLE Colonial
7. **ALTERATIONS**
 Rear of building has been pushed back, side wing added. The doorway appears to have been changed, possibly early in the 19th century. Chimney also appears to have been rebuilt. Modern aluminum storm sash, modern asphalt roofing.
8. **NOTABLE FEATURES**

9. **ARCHITECTURAL-HISTORICAL**
 Much altered, this house is in need of restoration to preserve its historic character. At a critical transition point in the commercial development of the Post Road, it is potentially an important support element in holding the line with Nos. 1139 and 1153. It retains its strong Colonial facade.
