HISTORIC RESOURCES INVENTORY:
 Buildings & Structures

SURVEY OF GUILFORD, NEW HAVEN COUNTY, 06437
 June-December 1981

1. **ADDRESS** 32 Boston Post Road
(map 43, lot 1)
2. **NAME**
(historic)
NAME
(common)
3. **USE**
(historic)
USE
(present) Private house, apartments
4. **IF MOVED, WHEN AND FROM WHERE:**

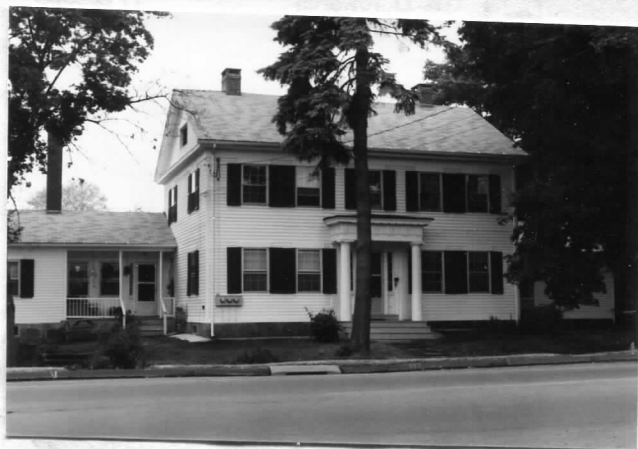
5. **ARCHITECT**
6. **DATE** c1825 **BUILDER**
STYLE Greek Revival
7. **ALTERATIONS** Asphalt shingles on roof; otherwise the house appears little changed. The posts and railings on the side porches do not seem original, but they are symmetrically identical and were evidently added by an owner who still cared about the precision of the building's design.
8. **NOTABLE FEATURES**

An important and ambitious house in its time and a good example today of the way in which the high style of the big towns was modified in the local vernacular. Although the central block, with its broad 5-bay facade and pitched roof, is still Colonial-Federal in form, the tripartite plan with low symmetrical flanking wings and recessed porches is that of an elegant Greek Revival mansion. Also Greek Revival are weighty lines of the roof and such details as the frieze and lintel and triglyphs (all the "correct" vocabulary of the Doric order), was a lavish gesture on the owner's part--probably the most splendid in town and today unique. Notice also the foundation of 5' granite slabs.
