HISTORIC RESOURCES INVENTORY:
Buildings & Structures

SURVEY OF GUILFORD, NEW HAVEN COUNTY, 06437
June-December 1981

1. ADDRESS 35 Boston Post Road
(map 43, lot 5B)
2. NAME
(historic)
NAME
(common)
3. USE
(historic)
USE
(present) Private house
4. IF MOVED, WHEN AND FROM WHERE:

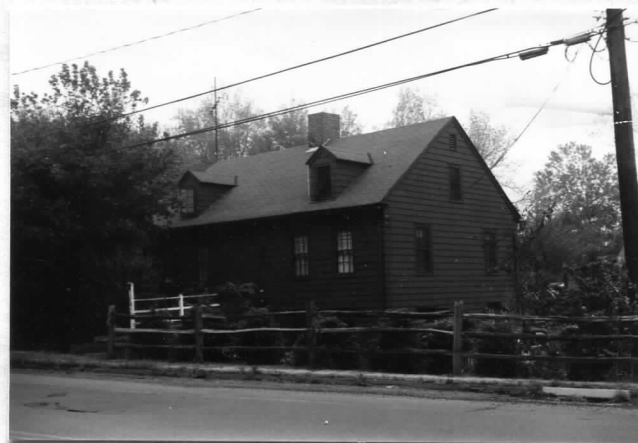
5. ARCHITECT
6. DATE 1809
- BUILDER
STYLE Late Colonial
7. ALTERATIONS
Dormers added. Whether the ground to the east was later cut away to allow the addition of a lower story, or whether this arrangement is original, is not known.

8. NOTABLE FEATURES
An example of the importance of landscaping to architecture. The distinction of this everyday small house results chiefly from the two levels of ground and the retaining walls, stone steps, stone slab path, and barns that outline a sort of

9. ARCHITECTURAL-HISTORICAL
sunken yard around the lower floor. Sad to say, in a recent rebuilding of the East River bridge, the State drastically widened the road and clipped the edges of the property, injuring its intimacy and tiny scale. In self-defense the owners have planted evergreens, and soon the place will be invisible. Formerly the house was light in color, and its lines showed up in relation to the levels and wall around it. It was one of the pleasures of driving into Guilford from the east.
The house itself remains a typical example of the one-and-a-half story house of the Federal period, ornamented only by its door with two transom lights. For more information about this river-side neighborhood, see 32 Boston Post Road.
