HISTORIC RESOURCES INVENTORY:
 Buildings & Structures

SURVEY OF GUILFORD, NEW HAVEN COUNTY, 06437
 June-December 1981

1. **ADDRESS** 113-115 Boston Street
 (map 40, lot 142)
2. **NAME**
(historic) Jared Buell
NAME
(common)
3. **USE**
(historic)
USE
(present) Two-family house
4. **IF MOVED, WHEN AND FROM WHERE:**

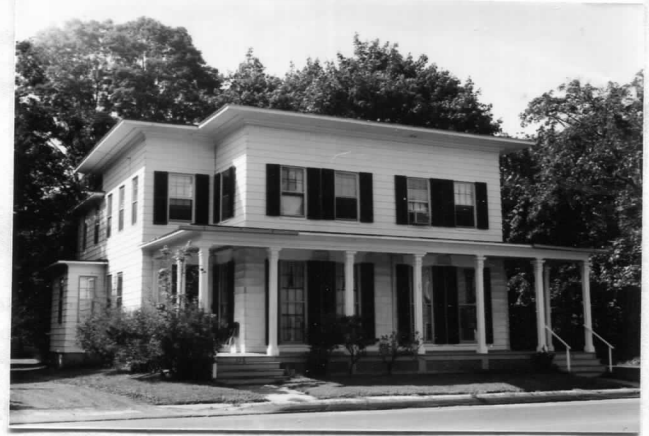
5. **ARCHITECT**
6. **DATE** c1850 **BUILDER**
- STYLE** Italian Villa
7. **ALTERATIONS**
 Aluminum siding of wide clapboards. If there was originally an entablature, as the height of the second story suggests, it is now covered. Wood railing on west steps modern.
8. **NOTABLE FEATURES**

9. **ARCHITECTURAL-HISTORICAL**
 A variant on the double-house theme (see 186-188 Whitfield Street), this is another design with traces of Henry Austin; specifically the square paneled columns of the porch, the very wide eaves with molding on the soffit, the eared doorframes, and the general broad symmetrical outline. The tall front windows with slim muntins are very elegant.

| <input type="checkbox"/> Excellent | <input type="checkbox"/> Good | <input checked="" type="checkbox"/> Fair | <input type="checkbox"/> Poor | <input type="checkbox"/> Bad |
