HISTORIC RESOURCES INVENTORY:
 Buildings & Structures

SURVEY OF GUILFORD, NEW HAVEN COUNTY, 06437
 June-December 1981

1. **ADDRESS** 147 Boston Street
(map 40, lot 139-H2)
2. **NAME**
(historic) Nathaniel Bishop
NAME
(common)
3. **USE**
(historic)
USE
(present) Private house
4. **IE MOVED, WHEN AND FROM WHERE:**
Formerly 42 Boston Street, site of
present parking lot. Moved c1976.

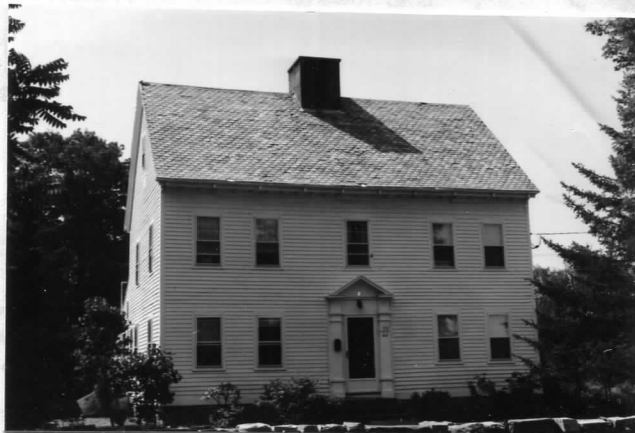
5. **ARCHITECT**
6. **DATE** 1755- **BUILDER**
STYLE Colonial
7. **ALTERATIONS** Rear additions. The chimney is evidently rebuilt and the fine slate roof, almost unique in Guilford, is probably late 19th century. On its former site, where it had been an office building, the house had a pair of bay windows on each side of the front door. These were changed back to reproductions of the original windows

8. **NOTABLE FEATURES** at the time of the move. The doorway looks as if it too may have had a history: first a Greek Revival frame with a flat top was probably added sometime around 1840, and then perhaps, about a century later, a Colonial enthusiast Georgianized it with the pediment. This house is notable for its vigorous steep lines and modillioned cornice and frieze. Since the photograph above was taken (1981), it has been painted dark grey and false shutters have been added, and attractive landscaping.
