HISTORIC RESOURCES INVENTORY:
Buildings & Structures

SURVEY OF GUILFORD, NEW HAVEN COUNTY, 06437
June-December 1981

1. ADDRESS 171 Boston Street
(map 40, lot 134)
2. NAME
(historic) Thomas Griswold III
NAME
(common) Guilford Keeping Society
3. USE Private house
(historic)
USE
(present) Historical society and museum
4. IF MOVED, WHEN AND FROM WHERE:

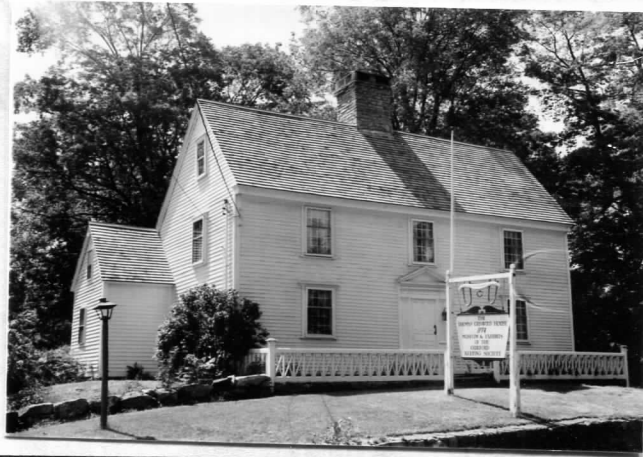
8. NOTABLE FEATURES
Simple but effective Georgian doorway with fluted pilasters, pulvinated frieze, and a fine paneled door. The siting of this house on a high ledge at a curve of the road, with its distinctive fence delineating the edge of the bank, is memorable.

9. ARCHITECTURAL-HISTORICAL
Built by Thomas Griswold for his two sons, Ezra and John, the house was lived in by four more generations of the Griswold family until the Guilford Keeping Society bought it from Robert Griswold Deforest's conservator in 1958. Extensive restoration was undertaken in 1974-75: rear dormers, screen porch, and shed were removed, restoring the original saltbox shape; a fireplace ten feet wide was also uncovered in the kitchen, exposing two original beehive ovens and a warming oven. In 1938 the Federal Writers' Guide wrote: "an attractive white salt-box dwelling on a high bank, behind an odd picket fence. Its excellent state of preservation and its charming setting have caused it to be the most photographed house in Connecticut." The "odd" fence was originally the railing on the belfry of the North Church that once stood on the Guilford Green.
