HISTORIC RESOURCES INVENTORY:
 Buildings & Structures

SURVEY OF GUILFORD, NEW HAVEN COUNTY, 06437
 June-December 1981

1. **ADDRESS** 200 Boston Street
(Map 40, Lot 68)
2. **NAME**
 (historic) Hull's Garage
NAME
 (common) Knapp's Foundry
3. **USE**
 (historic) Garage
USE
 (present) Foundry
4. **IF MOVED, WHEN AND FROM WHERE:**

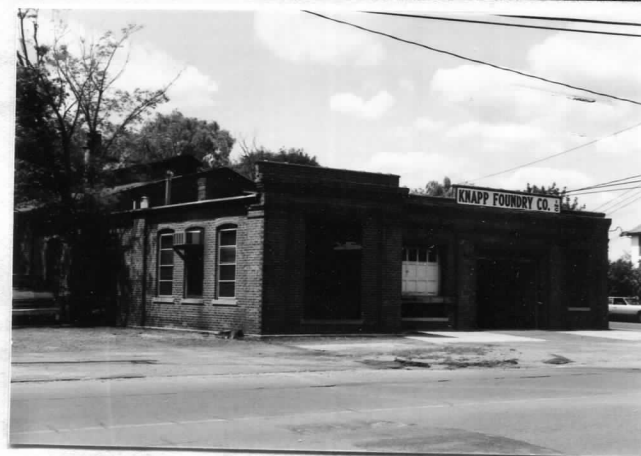
Negative ROLL 18.12A

5. **ARCHITECT**
6. **DATE** 1913
- BUILDER**
- STYLE** Industrial
7. **ALTERATIONS**
 Window openings boarded up; loading dock added, was originally a window

8. **NOTABLE FEATURES**
 Corbeling at the cornice line; brick pilasters used to divide bays in front and sides; segmental arched window openings; iron lintels with a star design.

9. **ARCHITECTURAL-HISTORICAL** This one story brick building was built in 1913 by George Edwin Hull and his sons, Herbert Pickering Hull and Sherman Bishop Hull, as a garage and automobile dealership. A projecting bay on the west end of the building has an opening now boarded up that occupies almost the entire bay, and must have once been a display window. The second bay also has a large display window opening that has undergone extensive alteration, this opening now serves as a loading dock. To convert the window into a loading dock a large wooden beam was placed approximately two feet up from the sill; damage to the brick work on the east end has resulted from the placement of this beam. The third bay contains a garage door. The two display windows and garage door have iron lintels with a star design. The fourth bay is a much smaller bay with a segmentally arched window, now boarded up, similar to the windows on (continued..)

the sides of the building. All windows have limestone sills. Brick corbeling appears at the cornice line.
