HISTORIC RESOURCES INVENTORY - BUILDING AND STRUCTURES

394 Boston Street

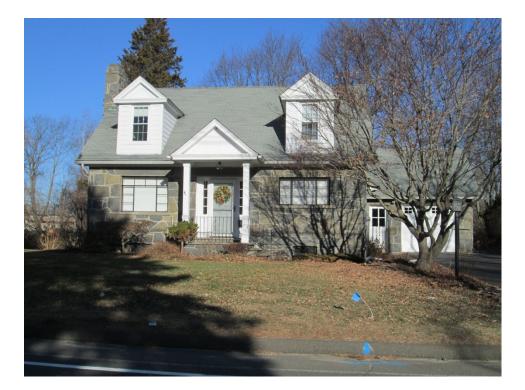
This one-story, Colonial Revival cape style dwelling is constructed of field stone and has a side-gable roof. The roof is covered in asphalt shingles. The three-bay facade faces south, and gable-roof dormers with pediments protrude from the slant of the roof. The main entry is centered on the facade and is reached by stone stairs with an iron railing. (See continuation sheet)

It is protected from the elements by a gable-roof overhang supported by slender posts. The fenestration consists of multi-paned iron stationary windows. A stone chimney runs up the west elevation of the house, and a garage addition was added to the east elevation.
