HISTORIC RESOURCES INVENTORY:
 Buildings & Structures

SURVEY OF GUILFORD, NEW HAVEN COUNTY, 06437
 June-December 1981

1. ADDRESS 45 Boston Street
(map 40, lot 156)
2. NAME
(historic) William Weld
NAME
(common)
3. USE
(historic)
USE
(present) Private house
4. IF MOVED, WHEN AND FROM WHERE:

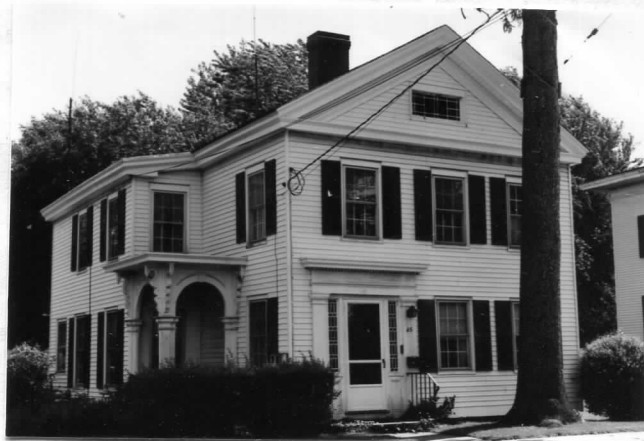
5. ARCHITECT
6. DATE 1850
- BUILDER William Weld
- STYLE Greek Revival
7. ALTERATIONS Rear addition; aluminum siding.
8. NOTABLE FEATURES See below

9. ARCHITECTURAL-HISTORICAL A classic of the Greek Revival, with main cornice drawn across the facade to form a pediment, with two flanking symmetrical wings, and an exceptionally splendid Doric door distinguished by a dentil course under the cornice and handsomely patterned sidelights. Gable window also handsomely patterned. Aluminum siding covers other trim, but judging by what is seen, the house is detailed with nicety. The flamboyantly overscaled side porch may have been added about ten years later at the time that Weld was building the house next door, for the two porches are nearly (but not quite) the same.
