HISTORIC RESOURCES INVENTORY - BUILDING AND STRUCTURES

Building Name (Common) 64 Boston Street
 Building Name (Historic) Richard J. Holmes House
 Street Address or Location 64 Boston Street
 Town/City Guilford Village _____ County New Haven
 Owner(s) Reilly Martin Family Trust Public Private

Style of building Greek Revival Date of Construction 1850 (Helander)

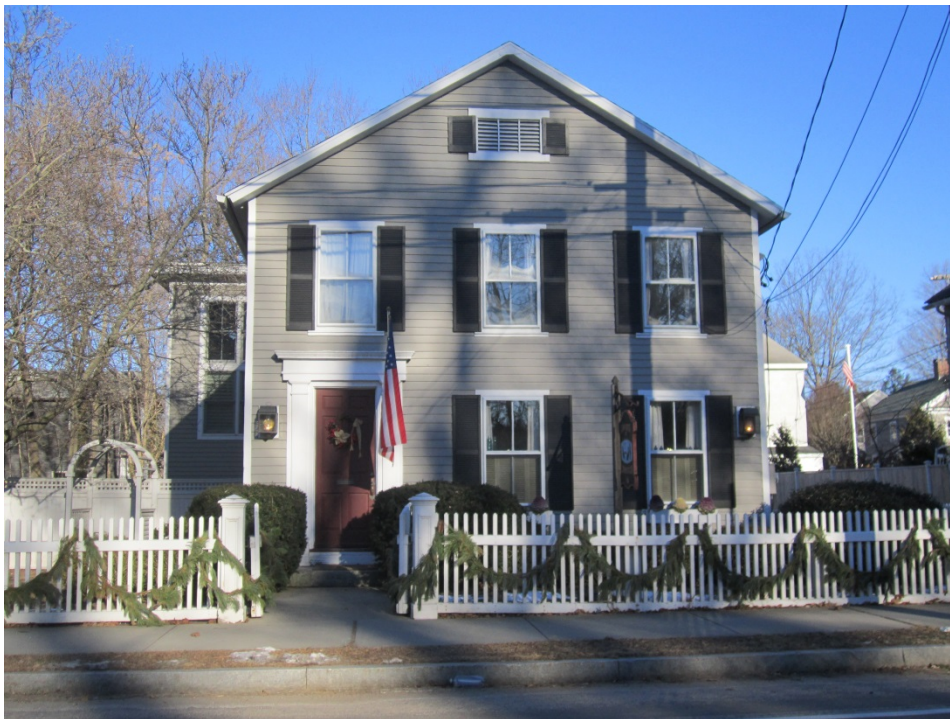
This is a two-story Greek Revival front-gable building. It is sheathed in clapboard siding and the roof is covered in asphalt shingles. The brick chimney is centered on the ridge-line of the roof. A square-shaped, hip-roof addition is attached to the north elevation of the building. The facade faces south and the main entry is on this side with a door surround, and is reached by a stone step. (See continuation sheet)

Photographer Kristen Nietering Date 1/17/2015
View South view of the house, camera facing north. Negative on File _____
Name Kristen Nietering Date 10/31/2015
Organization Guilford Preservation Alliance
Address 199 PO Box Guilford, CT 06437

The entry surround includes pilasters and a simple entablature. Fenestration includes one-over-one double-hung windows with shutters. In the attic is a louvered vent.
