HISTORIC RESOURCES INVENTORY:
 Buildings & Structures

SURVEY OF GUILFORD, NEW HAVEN COUNTY, 06437
 June-December 1981

1. ADDRESS 84 Boston Street
(map 40, lot 40)
2. NAME
(historic) George Hyland (also see
NAME below)
(common) Hyland House: The Dorothy
Whitfield Historic Society
3. USE
(historic)
USE Historical society and
(present) museum
4. IF MOVED, WHEN AND FROM WHERE:

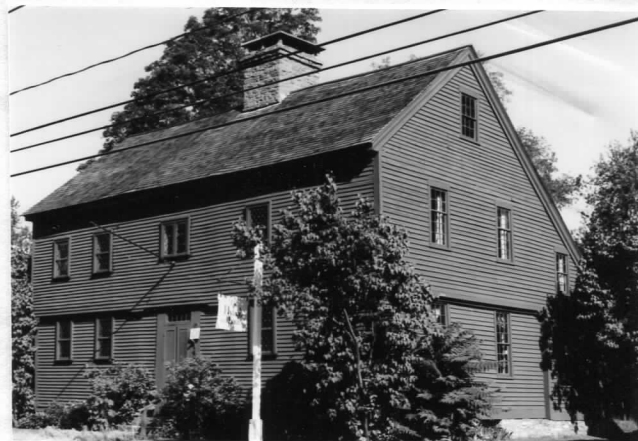
Negative ROLL 16:31A

8. NOTABLE FEATURES One of the best known and oldest remaining houses in Guilford. It is illustrated several times by Kelly, who refers to it as the Hyland-Wildman house and gives the date as c1660. Isham and Brown refer to it as the Fiske-Wildman house and believe the date to be c1720. Today, although no real documentation

9. ARCHITECTURAL-HISTORICAL can be found, a reasonably strong case has been made for the earlier date.
 The Hyland House is open to the public. It has been restored (Norman Isham, restoration architect) as far as possible to expose the work of its earliest period: notably the hewn overhangs with corbels and handsome chamfered beams on the exterior--a rarity in Connecticut; stair with molded box string, turned balusters, and pendants; 8 foot kitchen fireplace: and original clapboards are still visible in the leanto of the attic. The leanto on this house was added on after the house was built. The wainscotting in the room to the left of the front door (the hall) and the paneling in the room to the right (the parlor) are reproductions
