HISTORIC RESOURCES INVENTORY - BUILDING AND STRUCTURES

Building Name (Common) 88 Boston Street
 Building Name (Historic) Albert B. Wildman House
 Street Address or Location 88 Boston Street
 Town/City Guilford Village _____ County New Haven
 Owner(s) Eileen Charlsworth Public Private

Albert B. Wildman House/88 Boston Street

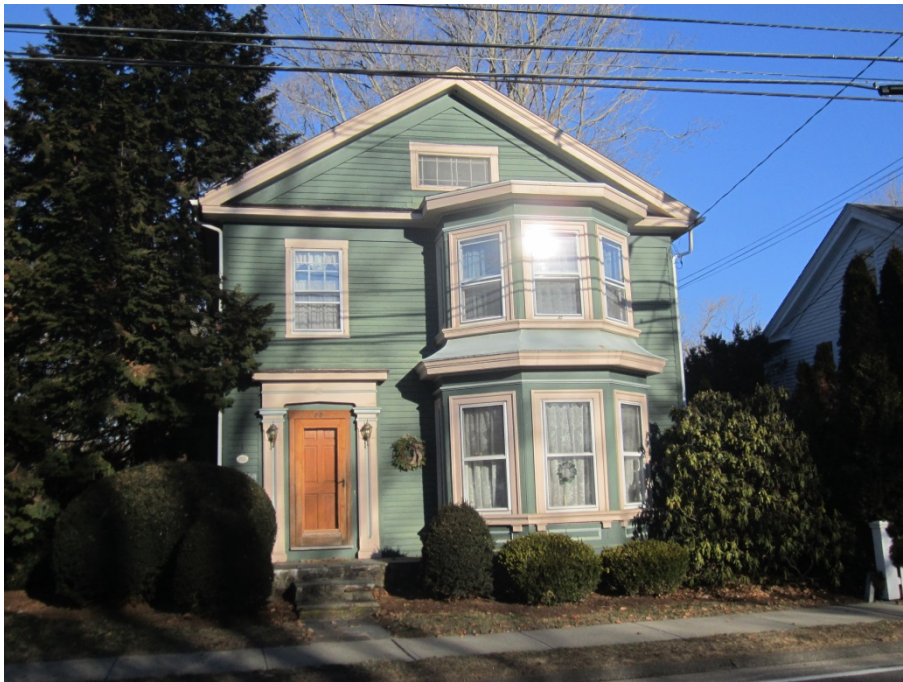
This is a two-story, front gable-roof, Greek Revival style house with a Queen Anne style two-story bay window. The Greek Revival features include a simple entablature door surround around and a full pediment in the gable. The main entry is found on the south facade and is reached by stone steps. To the east is a two-story bay window. Above the door is a six-over-one double-hung sash window. In the pediment is a rectangular window.

View South view, camera facing north. Negative on File _____
