**HISTORIC RESOURCES INVENTORY:**  
 Buildings & Structures

**SURVEY OF GUILFORD, NEW HAVEN COUNTY, 06437**  
 June-December 1981

1. **ADDRESS** 9 Boston Street  
(map 40, lot 163)
2. **NAME**  
*(historic)* Jasper Monroe & Sons  
**NAME**  
*(common)* Page's Hardware
3. **USE**  
*(historic)* General store  
**USE**  
*(present)* Hardware store
4. **IF MOVED, WHEN AND FROM WHERE:**

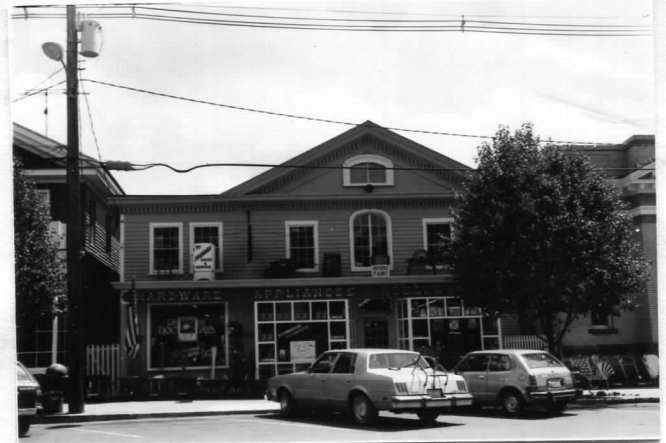
5. **ARCHITECT**
6. **DATE** 1858 **BUILDER** **STYLE** Greek Revival - Italianate
7. **ALTERATIONS**  
 Extension to east added. Front windows changed. Possibly the dentil course on the cornices is an addition dating from the Colonial Revival or from the time of the east extension.

8. **NOTABLE FEATURES**  
 The gable window curved at the top and richly enframed shows the Greek Revival style just changing into the Italianate. The two horizontal cornices do a good job of pulling the building together and minimizing the extension.
