HISTORIC RESOURCES INVENTORY:
Buildings & Structures

SURVEY OF GUILFORD, NEW HAVEN COUNTY, 06437
June-December 1981

1. ADDRESS 122 Broad Street
(map 39, lot 48)
2. NAME
(historic) Elisha Chapman Bishop
NAME
(common) Congregational Parish House
3. USE
(historic)
USE Private house
(present) Parish house
4. IF MOVED, WHEN AND FROM WHERE:

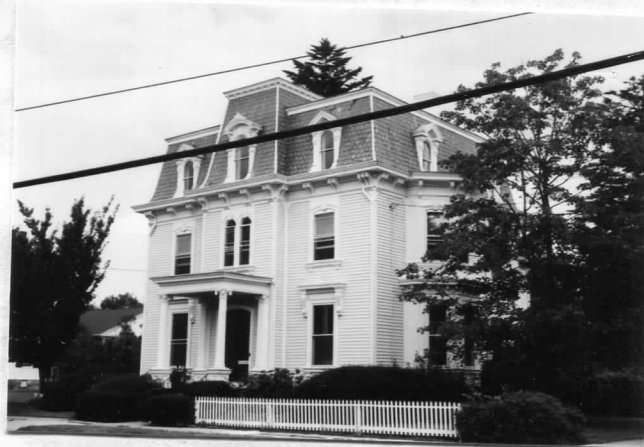
5. ARCHITECT Henry Austin
6. DATE 1874
- BUILDER Baldwin C. Dudley
- STYLE French Second Empire
7. ALTERATIONS Nothing major has changed, only little things: the rich Victorian fence that gave the place an air of opulence is gone (balusters preserved in the basement); also the elegant balustrade on the roof of the porch, echoing the fence; also the subtly two-toned color scheme that set off the (continued on next sheet)

8. NOTABLE FEATURES
The town's grandest production of the Reconstruction Era, one of the few instances where the Gilded Age touched Guilford. Lush consoles at the windows; slate roof with fanciful dormers; entry porch typical of mid-Victorian classicism, spaciously (continued on next sheet)

trim and animated the facade. Austin's drawings show iron cresting along the roof and top of the tower which was either never built or has been removed. Such details as these add up to a considerable difference in effect. (Also see #8 below)

scaled for an era of voluminous skirts; high foundation of very large granite blocks. Henry Austin's drawings are preserved by the Church and show that except for the details mentioned above, the exterior is unaltered. The plan was evidently changed somewhat in execution (as there are no working drawings or specifications it is possible that Austin was not involved in construction but merely sold the design either to the builder or to the Bishops directly), but except for plumbing, heating, electricity, and some resurfacing of ceilings (and perhaps floors?), the layout and all interior detail are intact. It is interesting to note that in a house so luxurious there was originally only one bathroom, supplemented by a built-in privy next to the butler's pantry.
