HISTORIC RESOURCES INVENTORY:
 Buildings & Structures

SURVEY OF GUILFORD, NEW HAVEN COUNTY, 06437
 June-December 1981

1. **ADDRESS** 29 Broad Street
(map 39, lot 70)
2. **NAME**
(historic) Abraham Coan house,
NAME later called "Mapleside"
(common)
3. **USE**
(historic)
USE
(present) Private house, barn, bowling alley
(for tower see adjoining sheet)
4. **IF MOVED, WHEN AND FROM WHERE:**

1. ADDRESS 29 Broad Street (Tower)
(map 39, lot 70)
2. NAME
(historic)
NAME
(common) Cranbrook Tower
3. USE
(historic) Windmill
USE
(present)
4. IF MOVED, WHEN AND FROM WHERE:

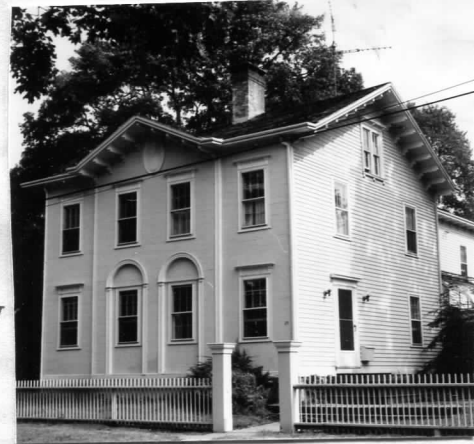
5. **ARCHITECT** See below
6. **DATE** Probably 1808
- BUILDER** Abraham Coan
- STYLE** Federal, Outbuildings later
7. **ALTERATIONS** Addition on rear and east side; greenhouse on west side. Door moved from front of house to side. A porch added to this side, later burned. For the problem of the roof and other additions, see below.
8. **NOTABLE FEATURES** Flushboarding, blind arcades, oval false window, quarter-round windows in east gable, window heads with carved frieze on facade. House, barn, bowling alley, tower, and spacious grounds make an architectural ensemble in a landscaped setting that is unique in Connecticut.
9. **ARCHITECTURAL-HISTORICAL**
See Continuation Sheet

It is to Chittenden's time that the barn belongs. This magnificent building is Guilford's most vivid essay in the Stick Style, with extravagantly wide eaves supported on free-standing diagonal braces, with an ornamental board overlay on the upper wall, and elaborately patterned doors. The cupola is puzzling, because it is not shown on the Birdseye View of 1881 but appears to be earlier.

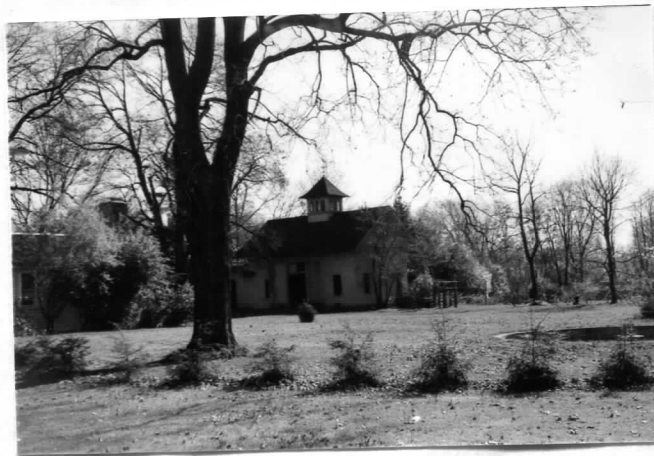
Two other spectacular buildings complete the remarkable ensemble: a stone tower, which is described on a separate Survey Sheet (29 Broad Street--Cranbrook Tower), and a bowling alley, the latter an enchanting fantasy, clearly matching the barn but with slim diagonal stickwork on the walls and, in the gable, one of the grandest pieces of pierced work in the New Haven area. It seems improbable that such stylish buildings as the alley and the barn--so unlike anything else in town--were not designed by an architect from New Haven or from the New York area where Chittenden's main residence was. Anna Lusk dates the bowling alley as 1868, and the barn must be about the same time. If the date is right, it puts them abreast of the advanced architecture of the day: work of this sort was just appearing in New Haven in the '60s, now mostly identified with Henry Austin and Donald Grant Mitchell. Chittenden might have gone to either of these men; he might also have turned to the New Haven builder and former colleague of Austin's, Nelson Hotchkiss, who had already done work on the First Church down the street (see 110 Broad Street and 96 Broad Street).

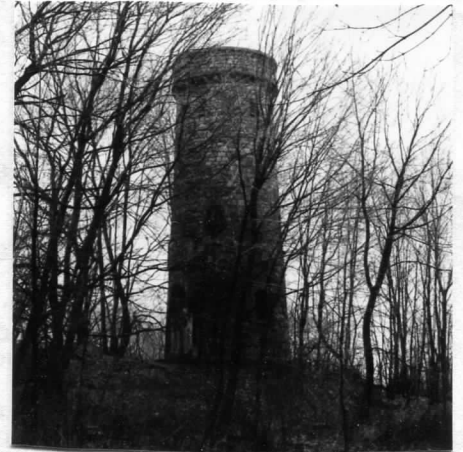
5. ARCHITECT
6. DATE 1869 BUILDER STYLE
7. ALTERATIONS Windmill was taken down and Tower roofed over in 1927, following the introduction of town water.
8. NOTABLE FEATURES Built of native granite, about 60' tall, the Tower has an iron stairway winding around the 4000 gallon water tank which is hand-riveted.
