HISTORIC RESOURCES INVENTORY:
 Buildings & Structures

SURVEY OF GUILFORD, NEW HAVEN COUNTY, 06437
 June-December 1981

1. **ADDRESS** 65 Broad Street
(map 39, lot 61)
2. **NAME**
(historic)
NAME
(common)
3. **USE**
(historic)
USE
(present) Private house
4. **IF MOVED, WHEN AND FROM WHERE:**

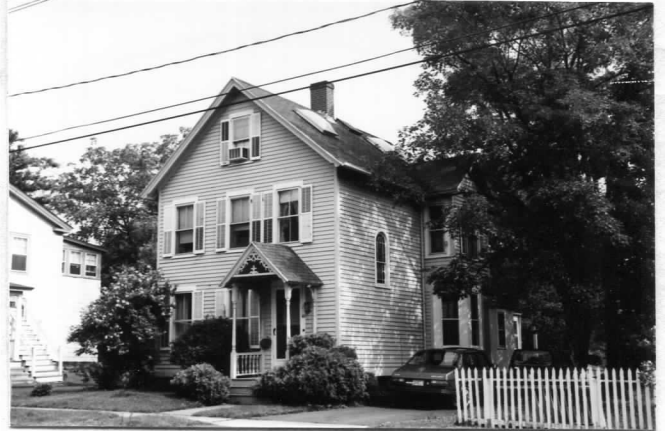
5. **ARCHITECT**
6. **DATE** Probably c1885-90 **BUILDER**
STYLE Vernacular Queen Anne
7. **ALTERATIONS**
 Rear addition and skylights, post - 1977.

8. **NOTABLE FEATURES**
 A small but lively porch adds vivacity in a sober Colonial neighborhood.
9. **ARCHITECTURAL-HISTORICAL**
 Queen Anne houses in Guilford are scarce and, like this one, generally modest in scale, blending successfully with the older streetscape. The date is uncertain. The house does not appear on a map of 1881 and is not mentioned in a deed of 1885, but judging by its style it must have been built soon after. The arched window on the west side is a lingering touch of the earlier Italianate style - a typical Guilford mixture.
