HISTORIC RESOURCES INVENTORY:
Buildings & Structures

SURVEY OF GUILFORD, NEW HAVEN COUNTY, 06437
June-December 1981

1. ADDRESS 6 Broad Street
(May 39, lot 14)
2. NAME
(historic) Caleb Stone
NAME
(common)
3. USE
(historic)
USE
(present) Private house and barn
4. IF MOVED, WHEN AND FROM WHERE:

1. ADDRESS 6 Broad Street (Barn)
(map 39, lot 14)
2. NAME
(historic) Site of William Leete house
NAME
(common) Regicide Cellar
3. USE
(historic) Barn
USE
(present) Barn and garage
4. IF MOVED, WHEN AND FROM WHERE:

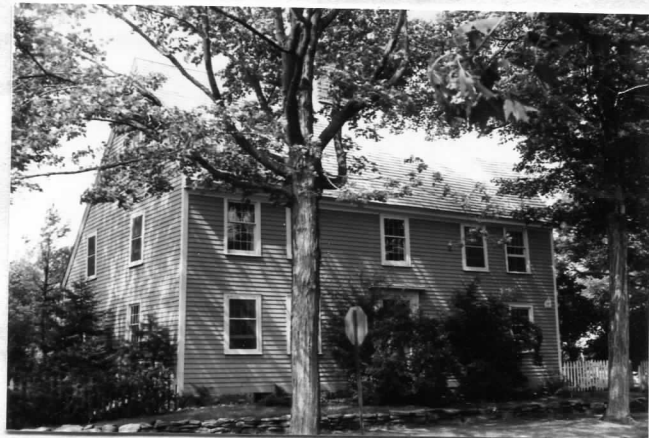
5. ARCHITECT
6. DATE 1749 BUILDER STYLE Colonial
7. ALTERATIONS Rear dormer added. Also see below.

8. NOTABLE FEATURES A 12-post plank house with integral leanto and secondary leanto added to the first. Original clapboards on what is now the inside wall of second leanto. Big stone chimney and foundation 2½' thick of large granite blocks with clamshell mortar. Chimney base 12'6" x 12'9". Doorway with 4 transom lights (but not the paneled door) possibly original.
9. ARCHITECTURAL-HISTORICAL

This well-kept saltbox is a fine example of an unpretentious 18th century Guilford house--severely plain, with little to detract from the sheer, steep outline and the purity of the geometric form. The rhythmic grouping of windows across the front, characteristic of houses of this period, is almost the only concession to conscious embellishment. The land is the homelot of William Leete, the colony's great and steadfast leader in its critical early years. After Whitfield and all the other elite of the founding company had left, he stayed behind, becoming the chief authority in Guilford, then Governor of the New Haven Colony, and finally Governor of Connecticut; and it was he who steered both town and colony through their most desperate period. His most heroic act, in the dark days after the Restoration, was (continued on next sheet)

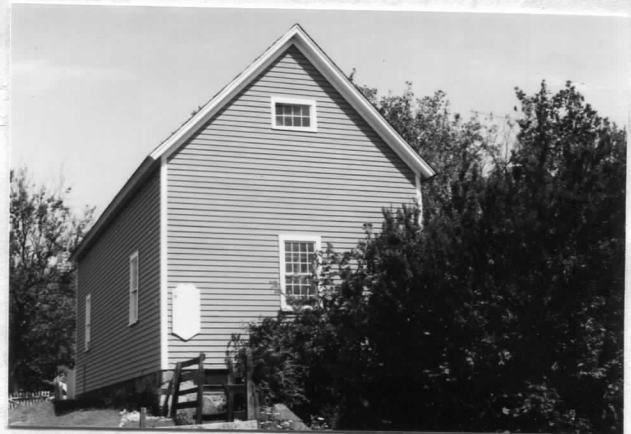
17th century cellar under the barn with curved north wall,
stonework for original stair, masonry with clamshell mortar.

9. ARCHITECTURAL-HISTORICAL For the history of this site see 6 Broad Street. According to tradition the cellar under the barn belonged to Governor William Leete's house, but some have questioned this, claiming that it was built for storage or a store of some sort. At any rate we know that it did belong to Governor Leete, and the spot is famous in Guilford today as the reputed hiding place of the regicide judges. A plaque on the barn tells the story: "Here in June 1661, Williame Leete, then Governor of New Haven Colony concealed for three days Whalley and Goffe, two of the judges who signed the death warrant of Charles I of England. They were sought by emissaries of Charles II who after the Restoration ordered the regicides beheaded." This story too has been questioned, but it remains a cherished Guilford legend.
