HISTORIC RESOURCES INVENTORY:
 Buildings & Structures

SURVEY OF GUILFORD, NEW HAVEN COUNTY, 06437
 June-December 1981

1. **ADDRESS** 61 Chimney Corner Circle
 (map 1, lot 28)
2. **NAME**
(historic) Sachem's Head Yacht Club
NAME
(common) Sachem's Head Yacht Club
3. **USE**
(historic) Yacht Club
USE
(present) Yacht Club
4. **IF MOVED, WHEN AND FROM WHERE:**

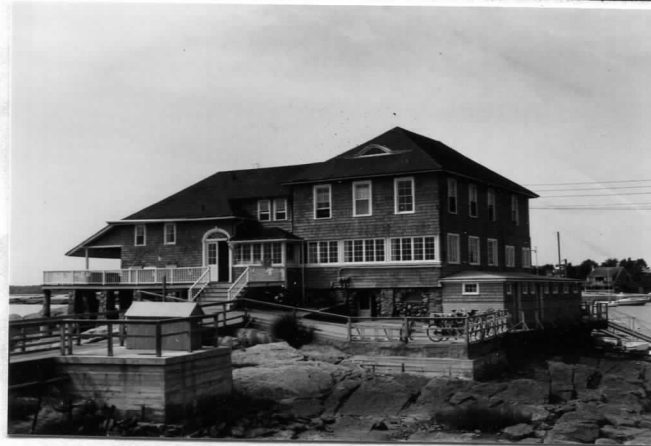
Negative ROLL 19:25

8. **NOTABLE FEATURES**
 Superbly sited on bare rock; shingles weathered a sea-grey with plain white trim in the classic seaside tradition; high narrow bridge leap-frogging from rock to rock.

9. **ARCHITECTURAL-HISTORICAL**
 It began as one of the characteristically pure and romantic buildings of the great period of seaside architecture in the '80s and '90s--built on a rock out in the water, surrounded by waves and reached only by a footbridge. A deep shadowy verandah ran all around under a long sloping roof that floated above it and gave the grey shingled mass a profile that seemed part of the coastline. A large three-story addition was made in 1901, unbalancing the serene composition, destroying the romantic image of the seascape. In the 1938 hurricane this was partly demolished, and the building was rebuilt in its present form. Architect's drawings for the 1901 addition are in the possession of H. Milton Bullard, Sachem's Head. No architect is named, but the initials "R.W.B." appear.
